HOUSATONIC WATER WORKS COMPANY WATER SYSTEM EVALUATION

Submitted to:
Town of Great Barrington, MA

June 29, 2021

Prepared by:
AECOM

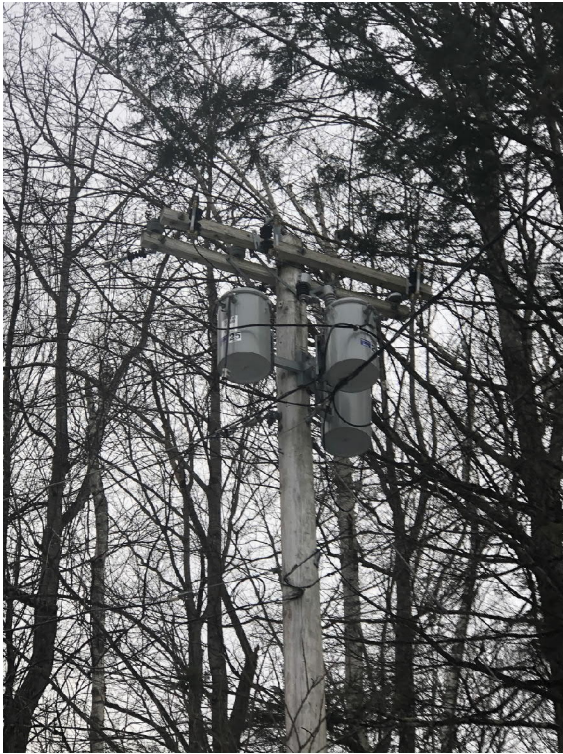
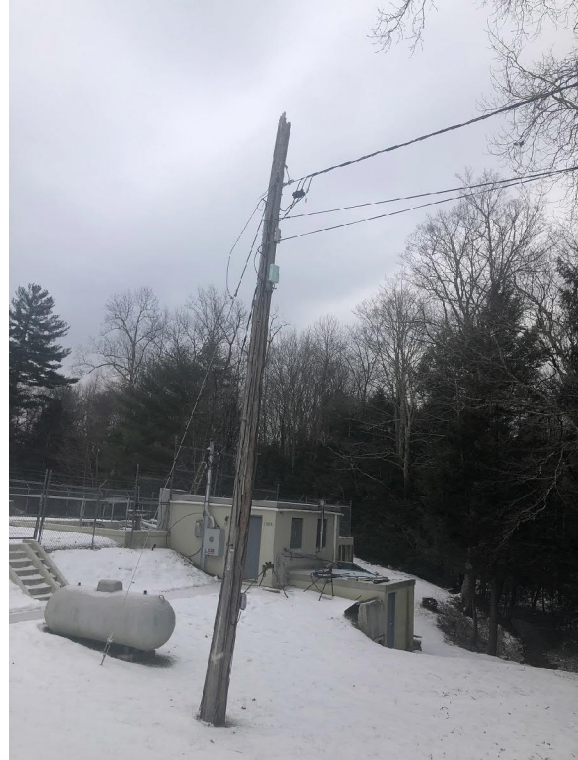
This last pole before the dam has what appears to be relatively new 3 phase transformers attached to it that feed the main facility with it's 208 / 120-volt service.

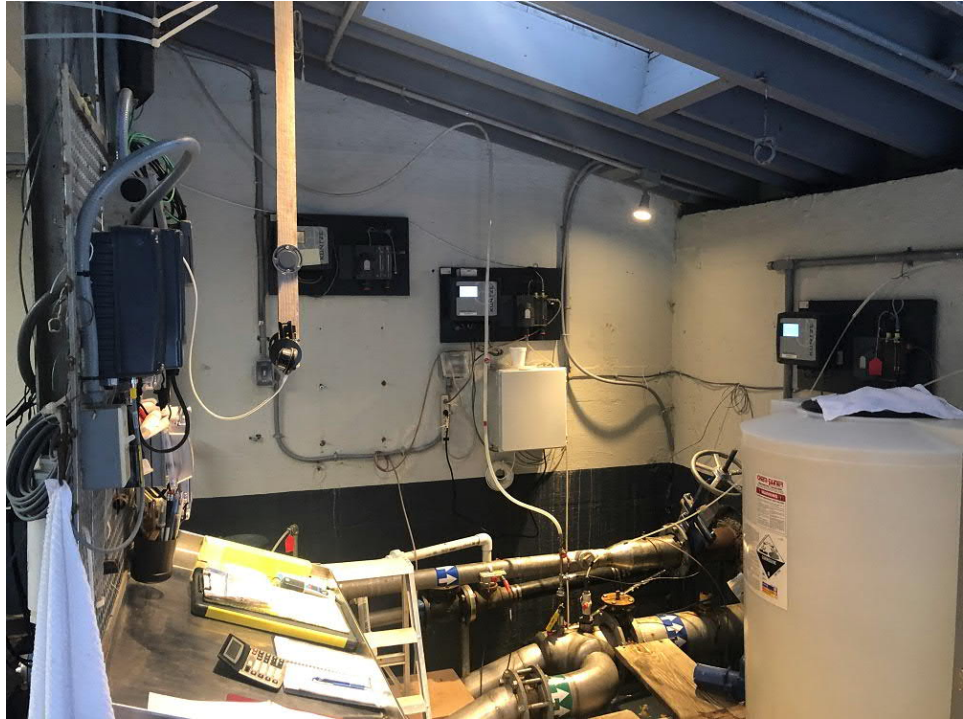
In the process area in general the instrumentation appeared not to be new but not essentially outdated either. Overall, I could not confirm that they were recently calibrated.

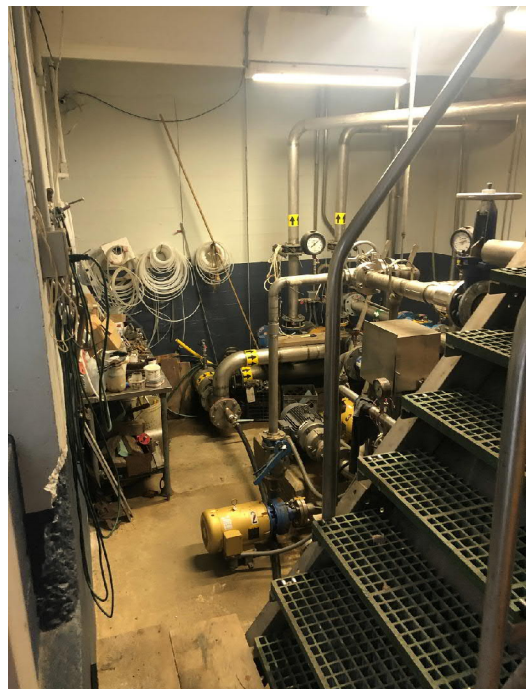
In the photo to the right, it was noted that several of the motors have been replaced with newer high efficiency motors. These would be the gold ones seen in the photo. Motors color coated in this manner was done some time ago to distinguish them from standard efficiency motors. So, they are high efficiency motors likely over 5 years old.

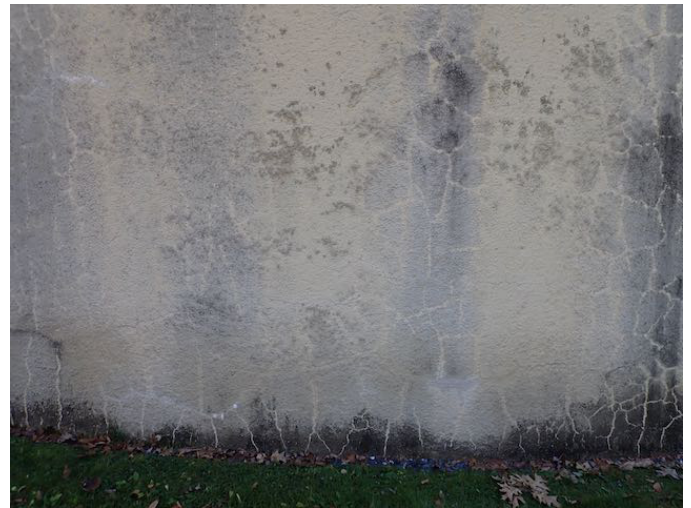
2 ***Exterior Wall Having Tight Cracks And A Non-Uniform Accumulation Of Mildew***

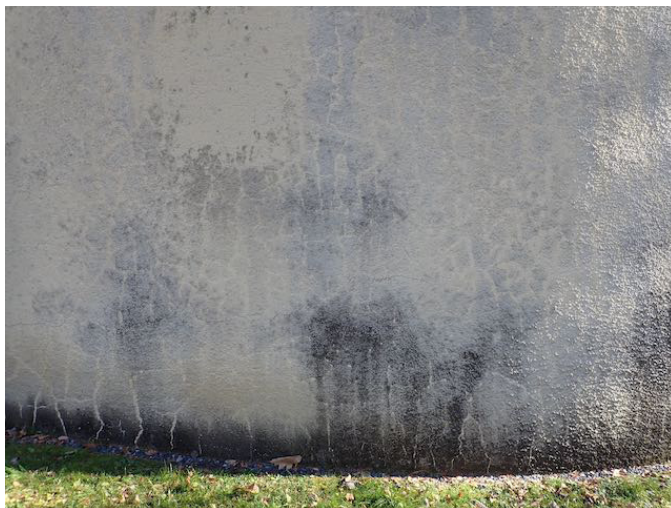
3 ***Exterior Wall Having Tight Cracks And A Non-Uniform Accumulation Of Mildew***

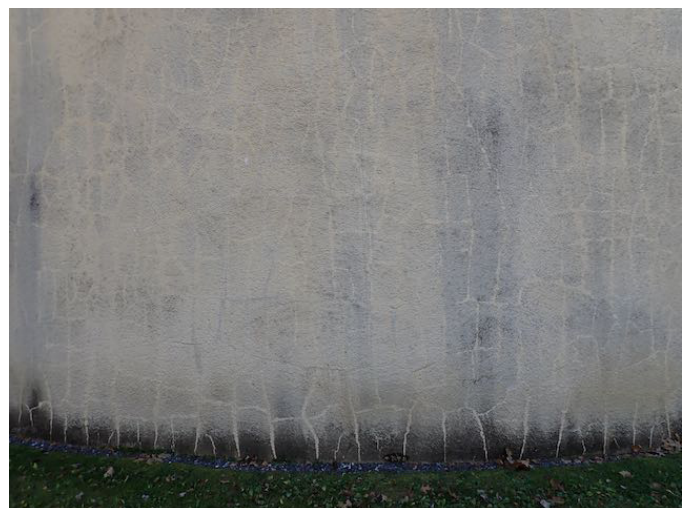
4 ***Exterior Wall Having Tight Cracks And A Non-Uniform Accumulation Of Mildew***

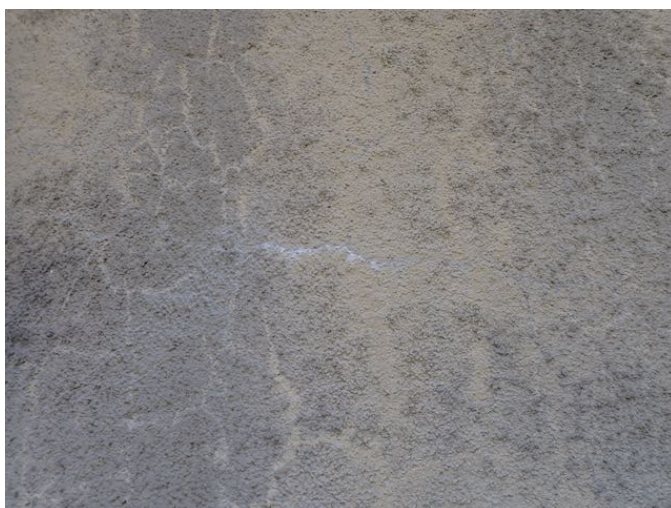
5 ***Exterior Wall Having Tight Cracks And A Non-Uniform Accumulation Of Mildew***

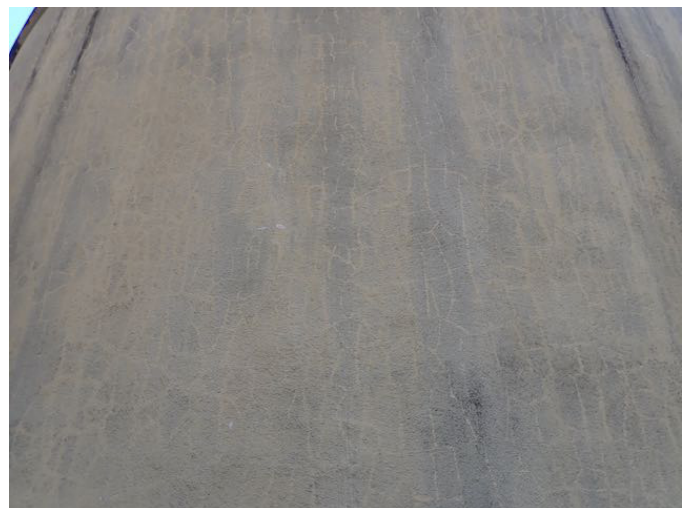
6 ***Exterior Wall Having Tight Cracks And A Non-Uniform Accumulation Of Mildew***

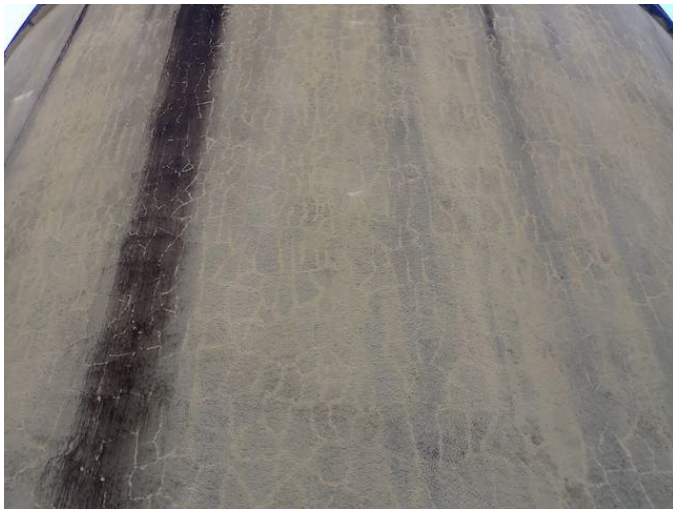
7 *Exterior Wall Having Tight Cracks And A Non-Uniform Accumulation Of Mildew*

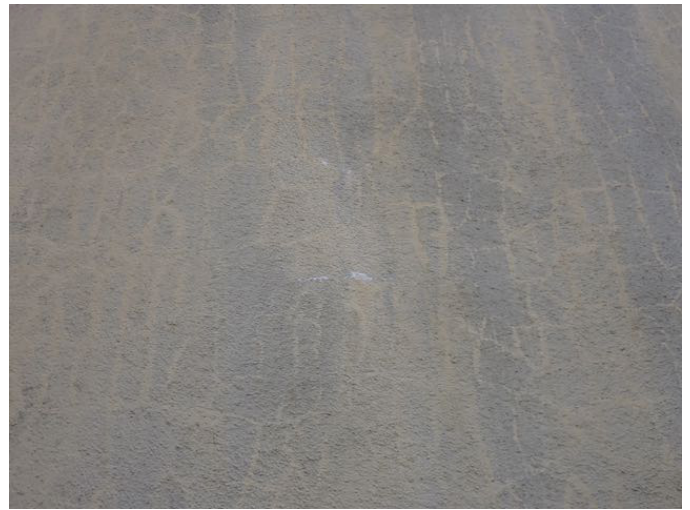
8 *Exterior Wall Having Tight Cracks And A Non-Uniform Accumulation Of Mildew*

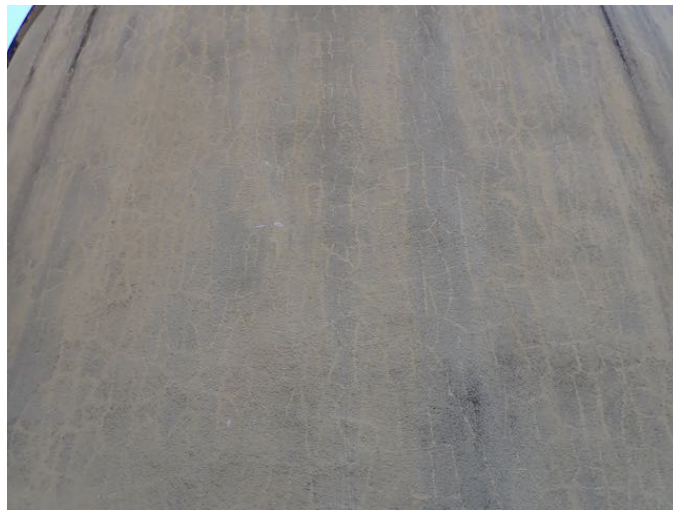
9 *Exterior Wall Having Tight Cracks And A Non-Uniform Accumulation Of Mildew*

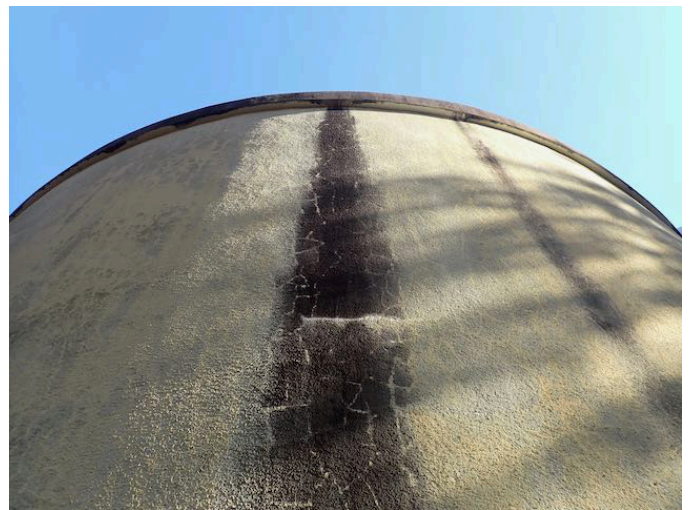
10 *Exterior Wall Having Tight Cracks And A Non-Uniform Accumulation Of Mildew*

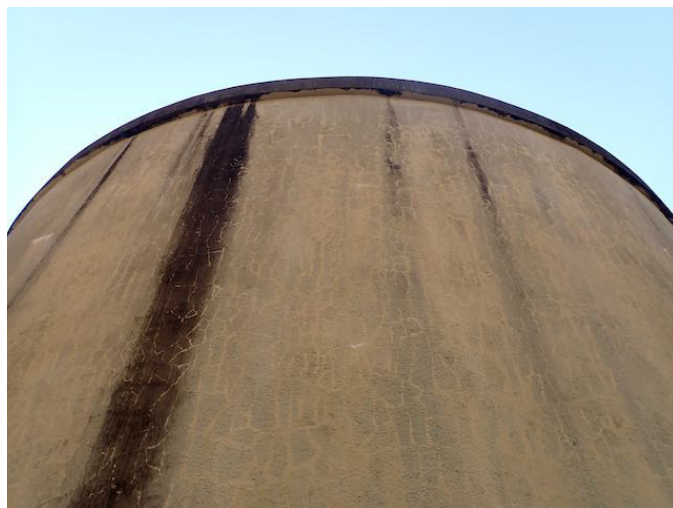
11 *Exterior Wall Having Tight Cracks And A Non-Uniform Accumulation Of Mildew*

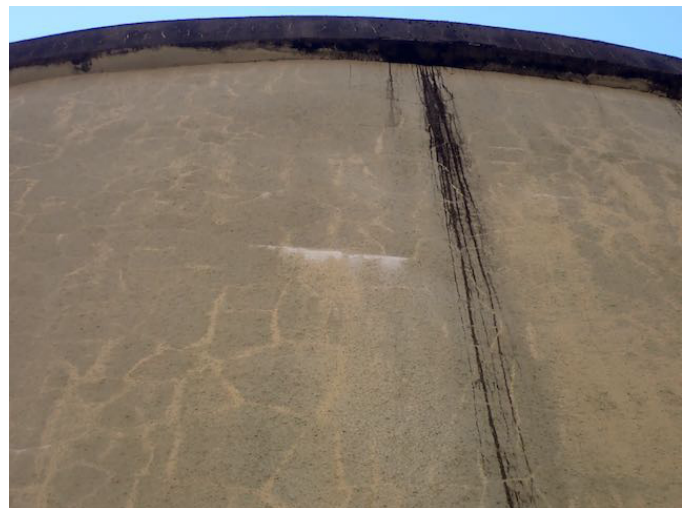
12 *Exterior Wall Having Tight Cracks And A Non-Uniform Accumulation Of Mildew*

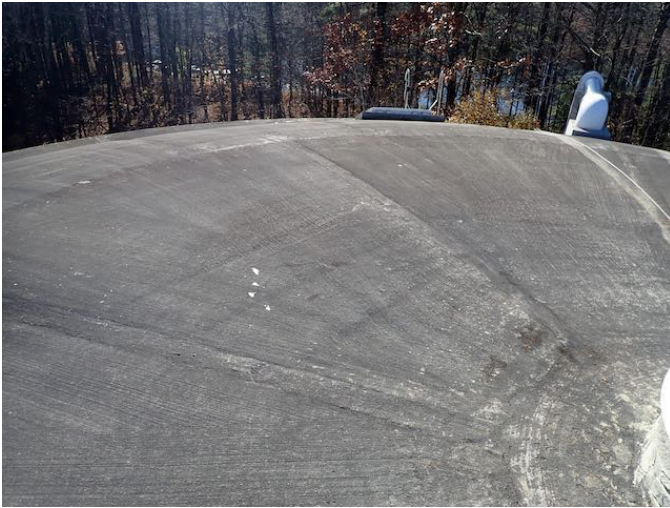
13 *Pre-Cast Concrete Roof Panels Appearing Sound And Having Tight Cracks Within The Concrete Filled Panel Joints And A Non-Uniform Accumulation Of Mildew*

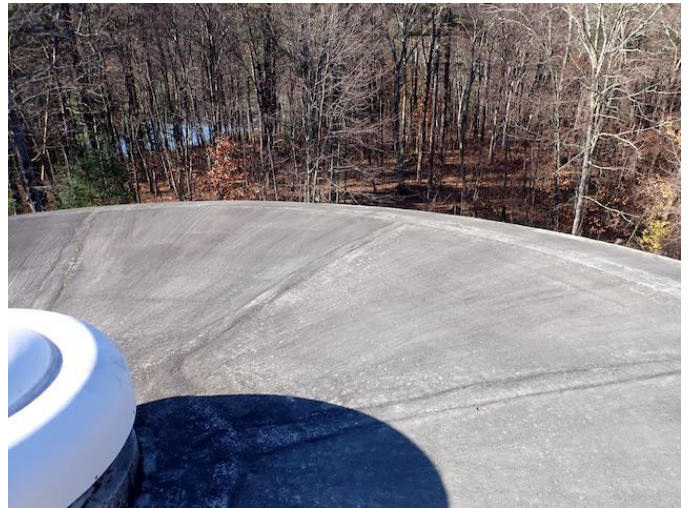
14 *Pre-Cast Concrete Roof Panels Appearing Sound And Having Tight Cracks Within The Concrete Filled Panel Joints And A Non-Uniform Accumulation Of Mildew*

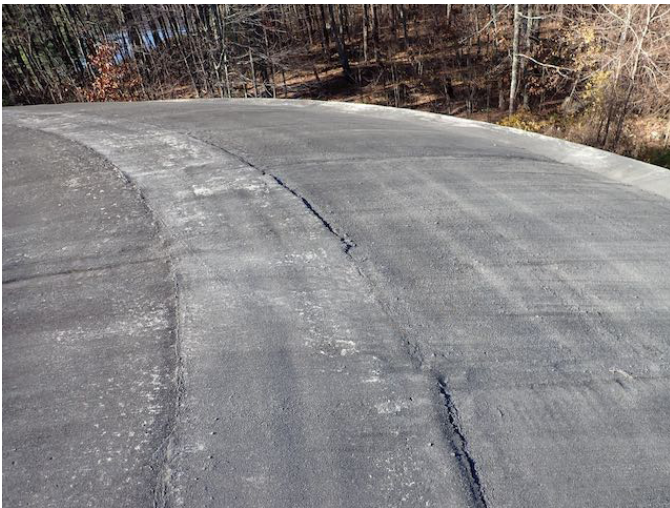
15 *Pre-Cast Concrete Roof Panels Appearing Sound And Having Tight Cracks Within The Concrete Filled Panel Joints And A Non-Uniform Accumulation Of Mildew*

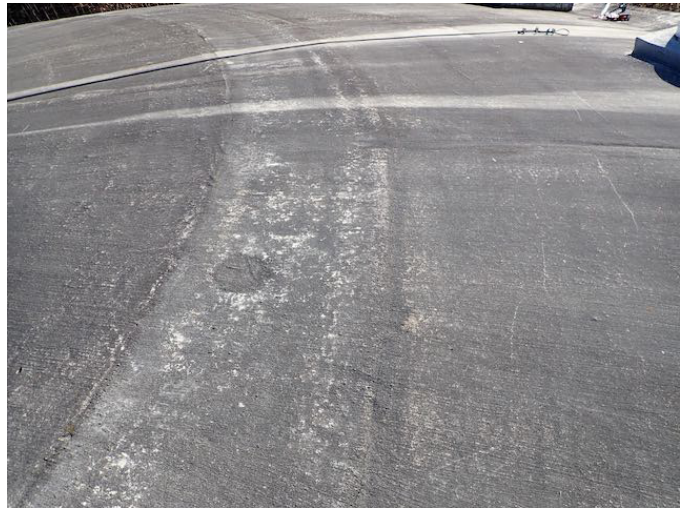
16 *Pre-Cast Concrete Roof Panels Appearing Sound And Having Tight Cracks Within The Concrete Filled Panel Joints And A Non-Uniform Accumulation Of Mildew*

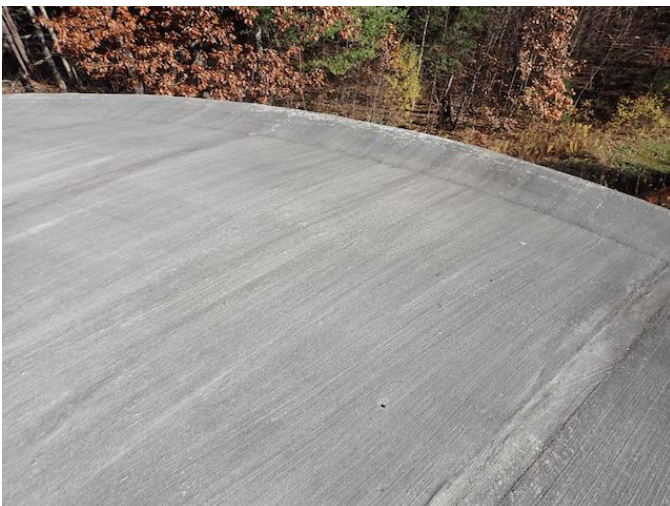
17 *Pre-Cast Concrete Roof Panels Appearing Sound And Having Tight Cracks Within The Concrete Filled Panel Joints And A Non-Uniform Accumulation Of Mildew*

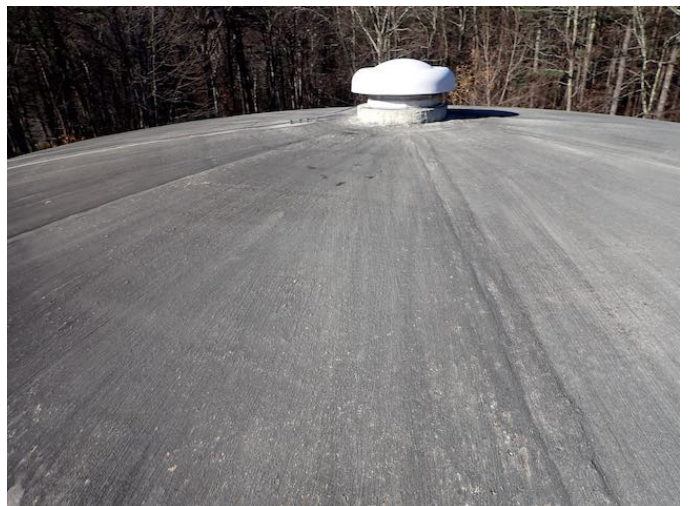
18 *Pre-Cast Concrete Roof Panels Appearing Sound And Having Tight Cracks Within The Concrete Filled Panel Joints And A Non-Uniform Accumulation Of Mildew*

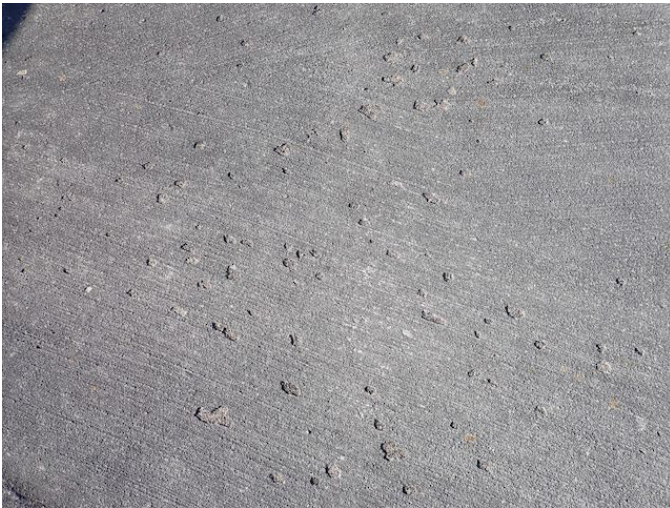
19 *Roof Having Adhesion Lost Of The Cement Based Protective Coating*

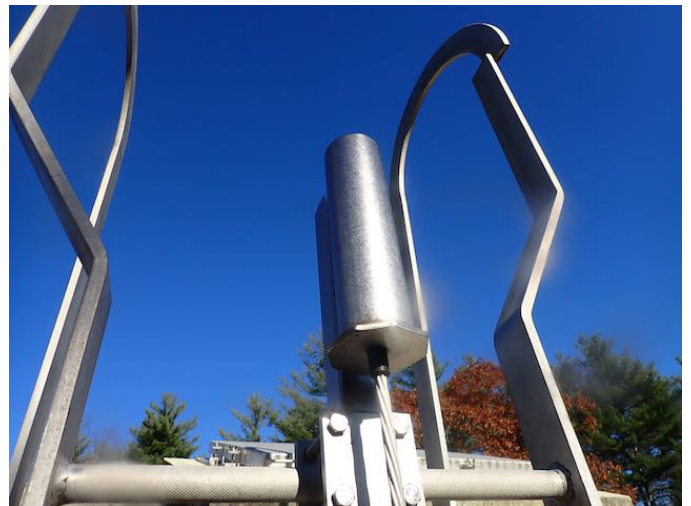
30 *Hand Rail On The Top , Right Side Of The Ladder Having A Failed Weld*

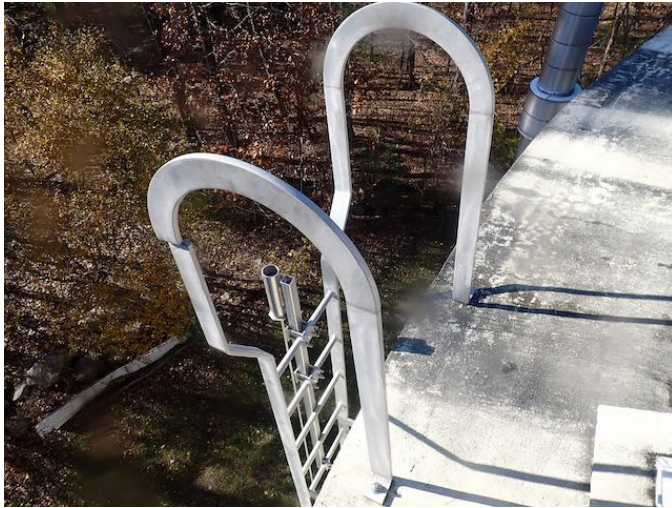
31 *Hand Rail On The Top , Right Side Of The Ladder
Having A Failed Weld*

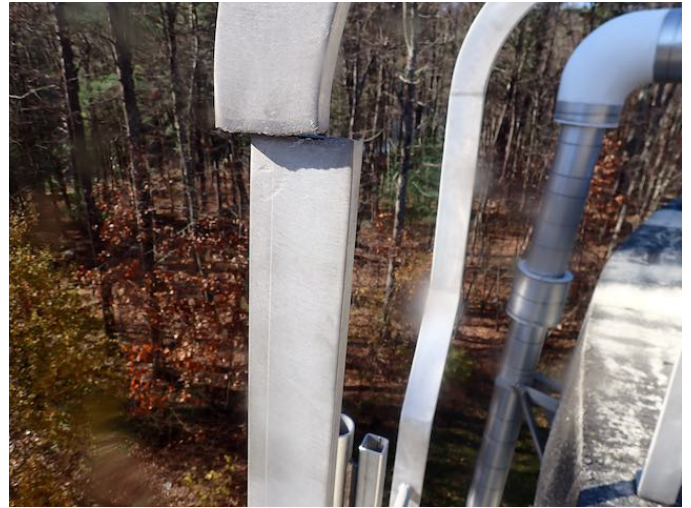
32 *Hand Rail On The Top , Right Side Of The Ladder
Having A Failed Weld*

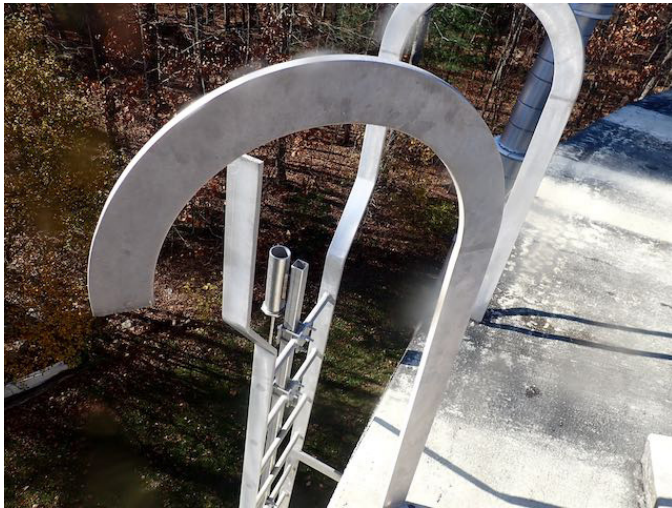
33 *Hand Rail On The Top , Right Side Of The Ladder
Having A Failed Weld*

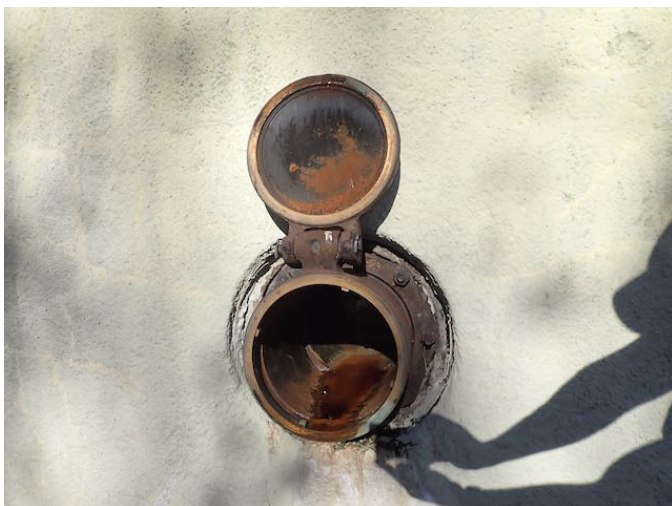
35 *Overflow Pipe Found Unobstructed*

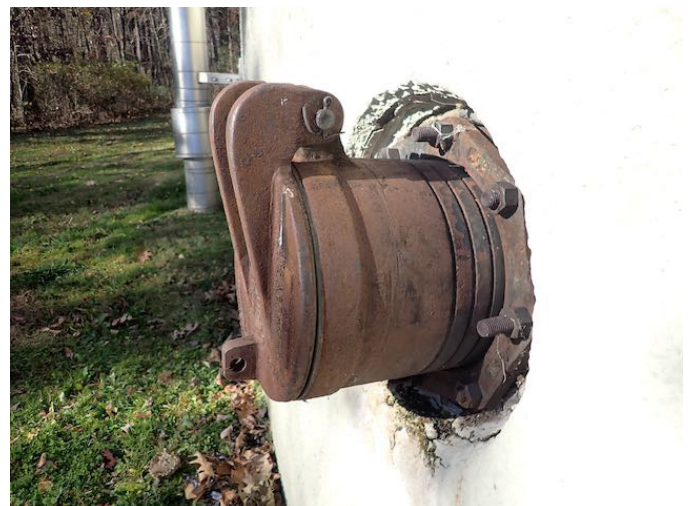
36 *Overflow Pipe And Flap-Valve Having Corrosion*

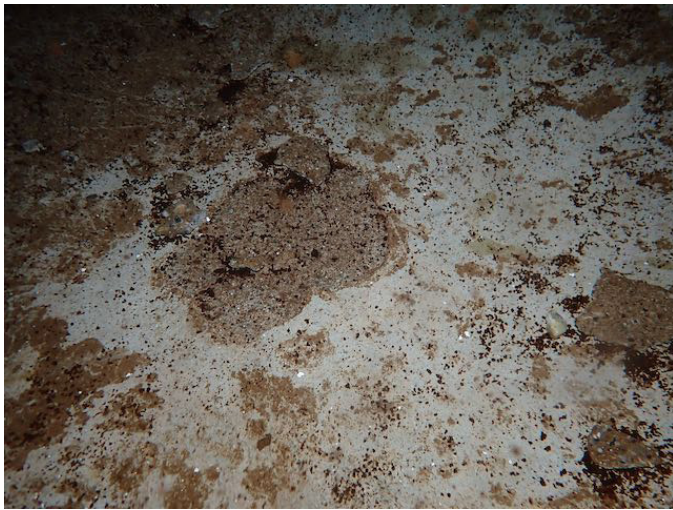
43 *Floor Appearing Sound And Having A Mild Stain*

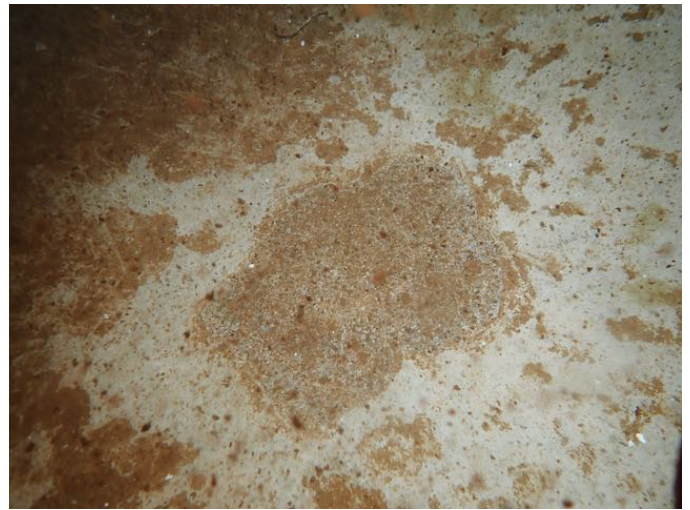
44 *Floor Appearing Sound And Having A Mild Stain*

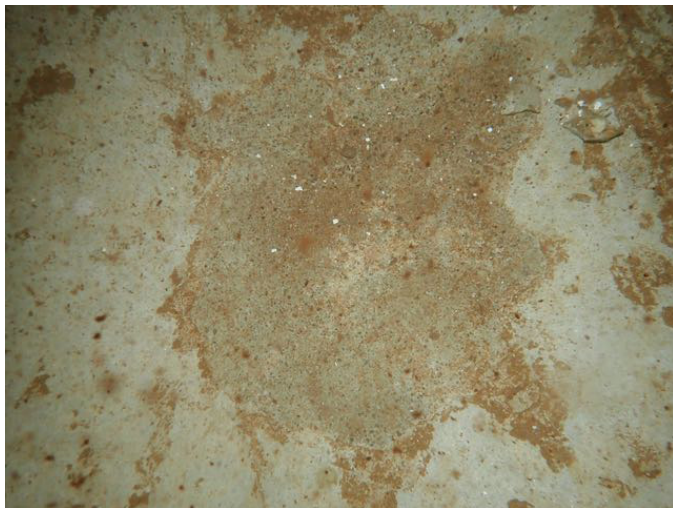
45 *Floor Appearing Sound And Having A Mild Stain*

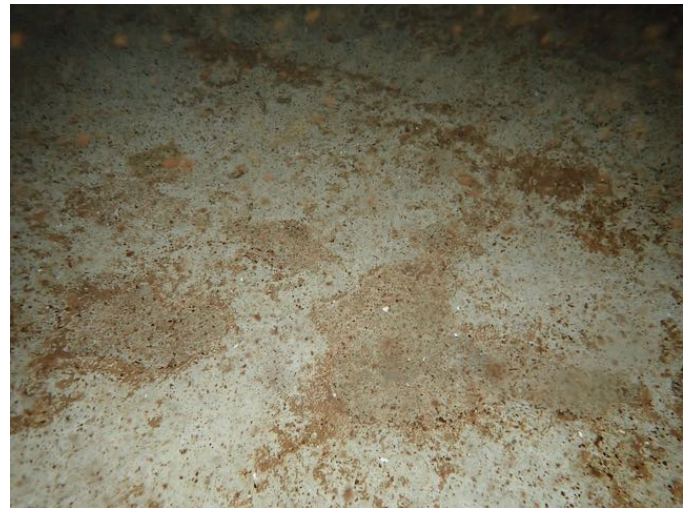
46 *Floor Appearing Sound And Having A Mild Stain*

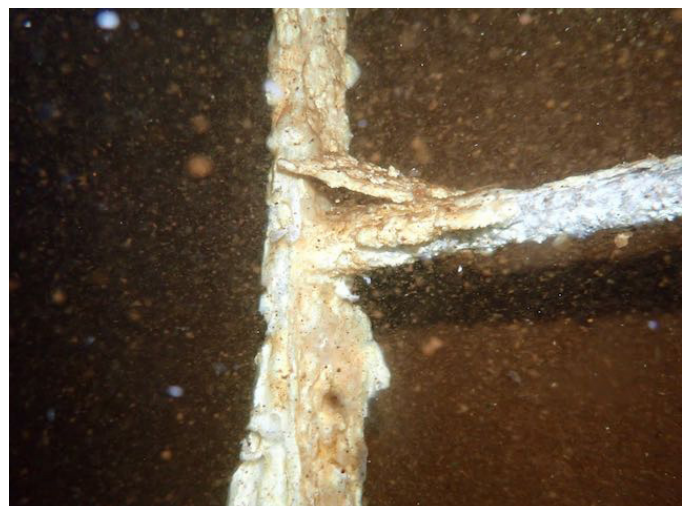
48 *Manway Access Ladder Having Corrosion*

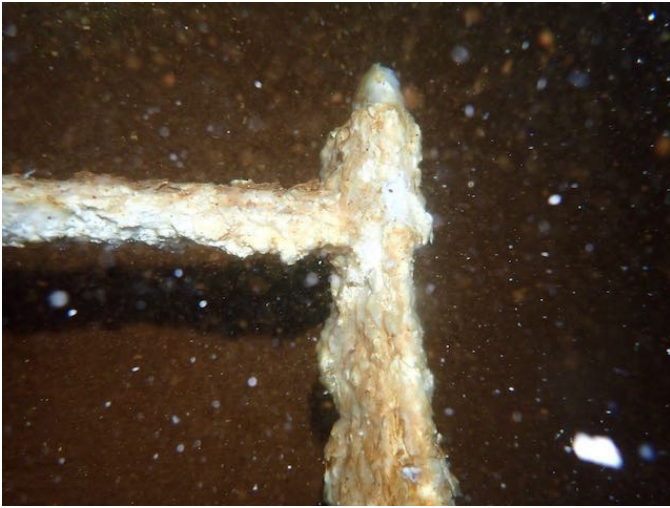
49 *Manway Access Ladder Having Corrosion*

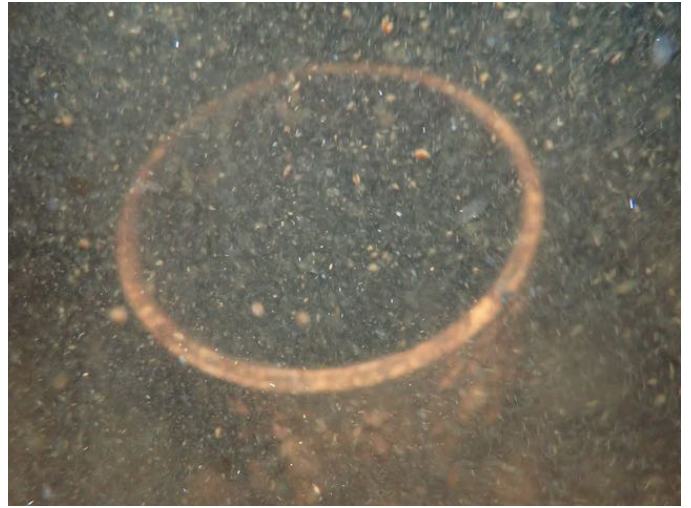
50 *Pipe Penetrating The Floor Found Unobstructed*

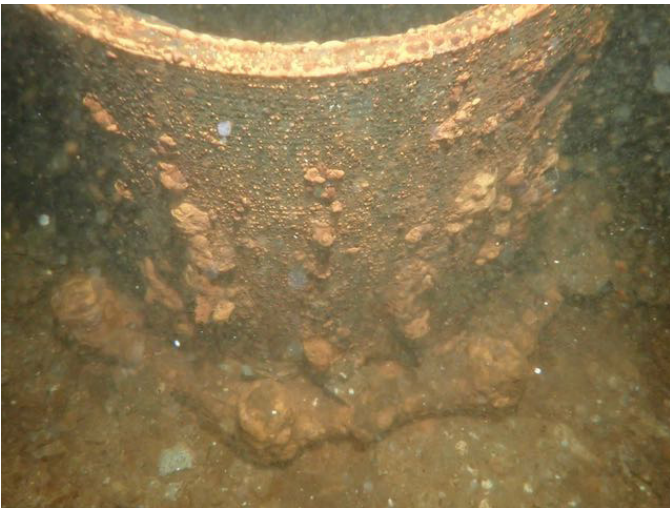
51 *Pipe Penetrating The Floor Having Corrosion*

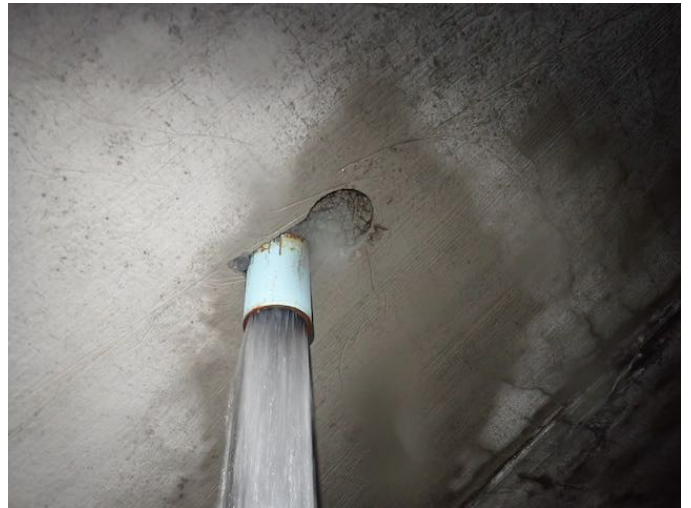
52 *Pipe Penetrating The Overhead Having Flow Entering The Tank*

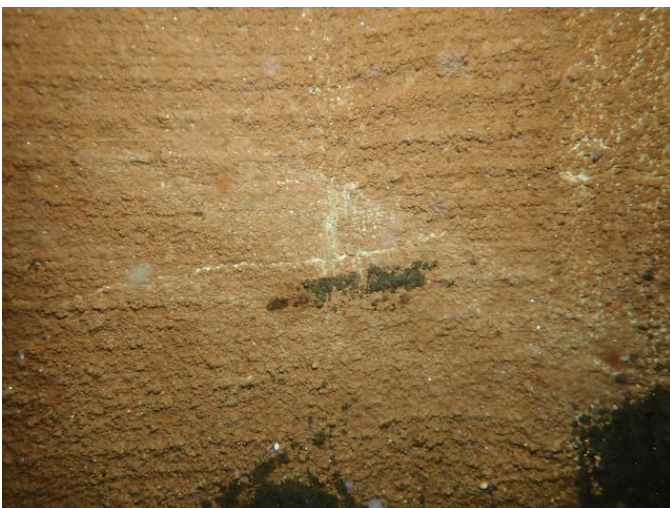
53 *Interior Wall Having Tight Cracks*

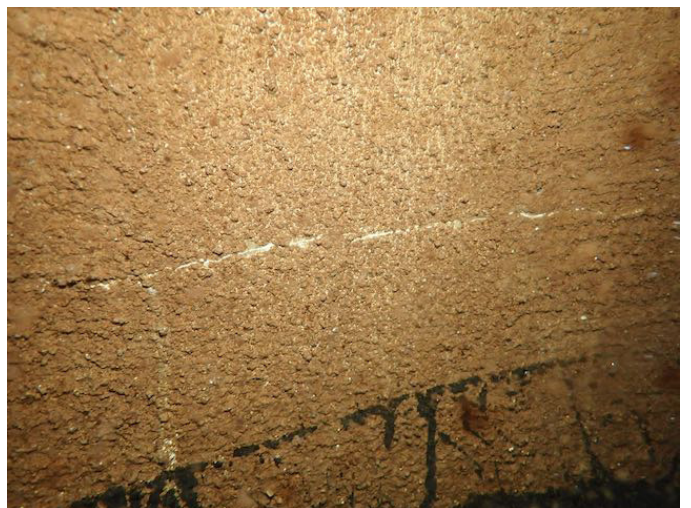
54 *Interior Wall Having Tight Cracks*

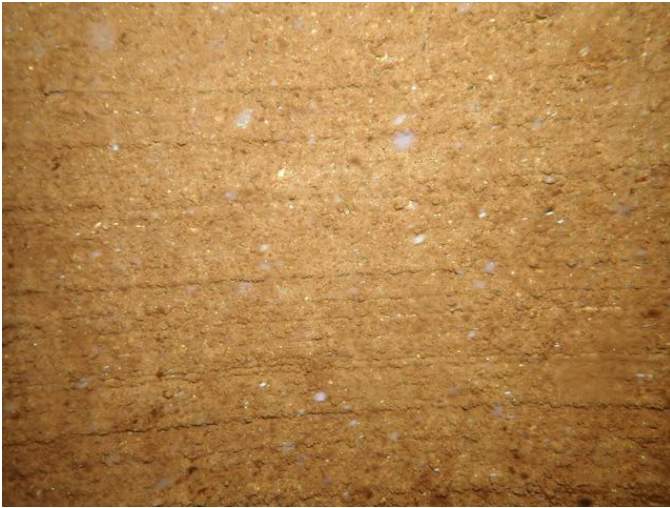
55 *Interior Wall Appearing Sound And Having A Mild Stain*

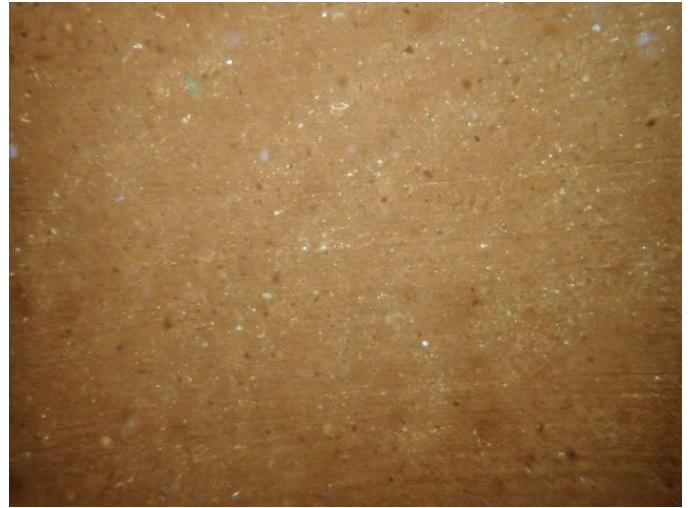
56 *Interior Wall Appearing Sound And Having A Mild Stain*

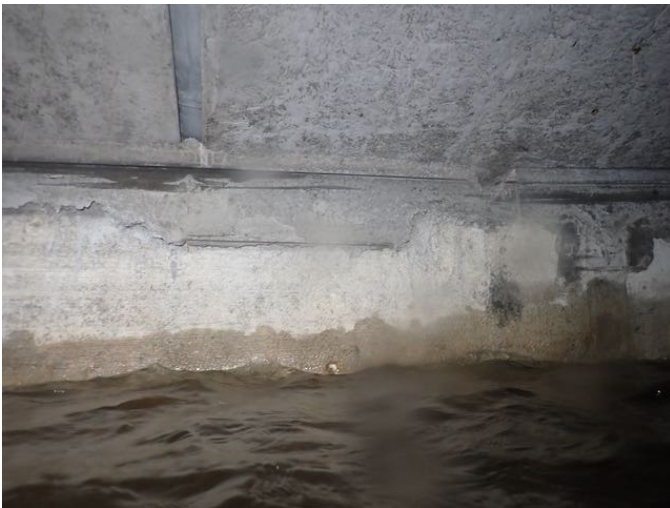
57 *Interior Wall Appearing Sound And Having A Mild Stain*

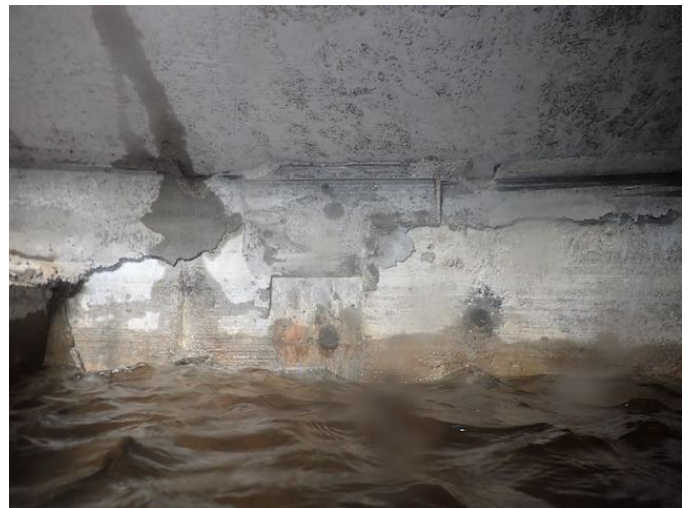
58 *Interior Wall Appearing Sound And Having A Mild Stain*

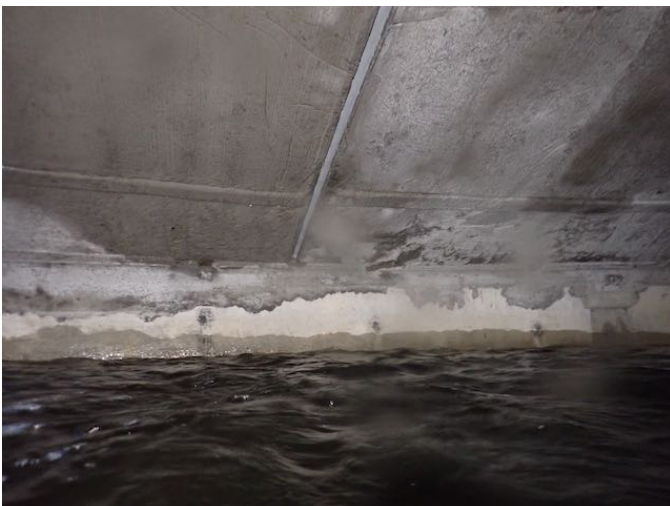
59 *Interior Wall Appearing Sound And Having A Mild Stain*

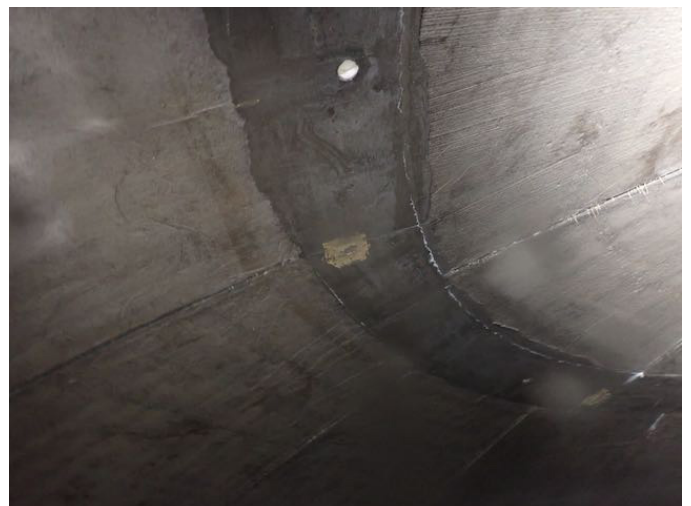
60 *Pre-Cast Concrete Overhead Panels And Concrete Filled Joints Appearing Mostly Sound*
