History and visual assessment of the Cottonwood at 85 Lake Buel Rd.

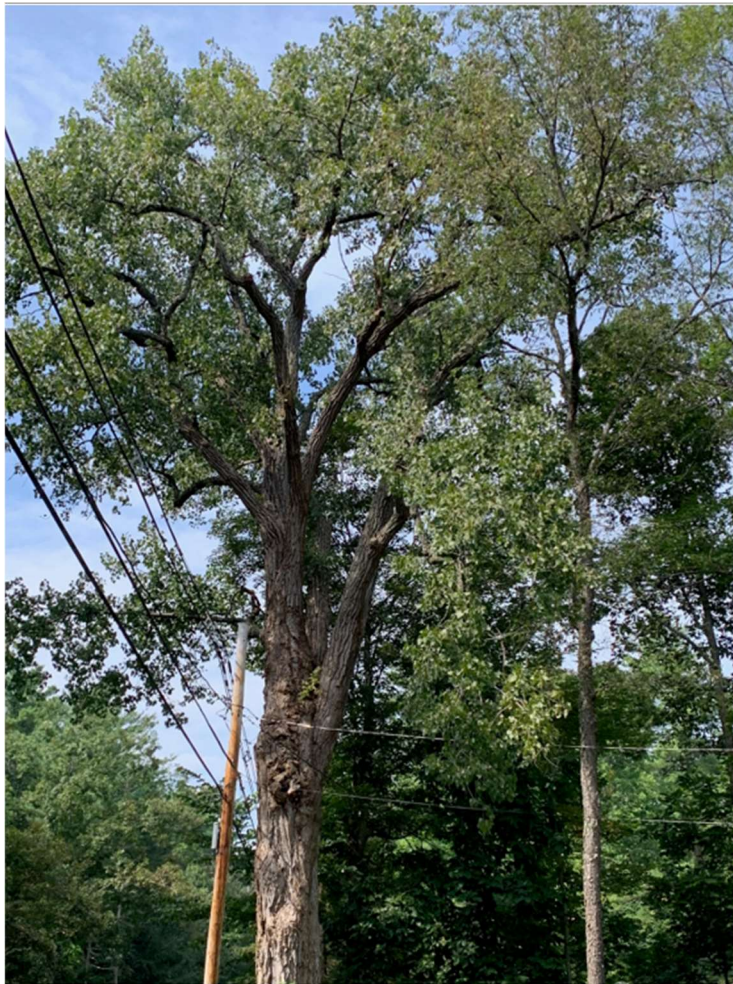
Located at 85 Lake Buel Road there is a large Cottonwood tree. Visual assessment of the tree confirms biological health but structural integrity and location issues. The tree is located at the edge of the road with main distribution lines located under the tree. This presents challenges as Cottonwood is a weak wooded species prone to breakage in storms even when healthy. Given the trees size just about any failure in the tree on the road side will cause extensive damage to infrastructure and endanger the general public.

With all of this in mind National grid would like to remove the tree in order to eliminate any further damage to their infrastructure and to make the area safer for the homeowners nearby.

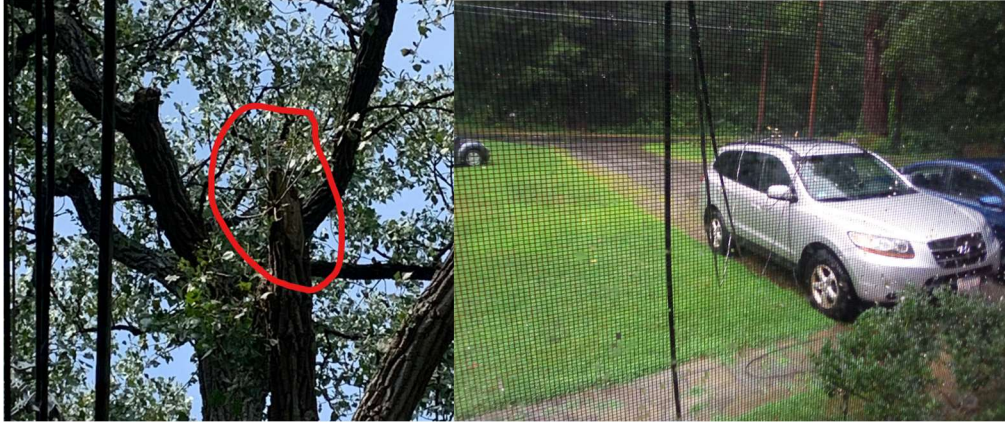
This specific limb failure resulted in the secondary line going to the homeowner's house to be taken down and onto their vehicles creating a safety hazard for the customer. There are multiple large limb failures in the tree and at my initial assessment in 2020 there was a large limb being suspended about 40' in the air by vines. It has since fallen or was removed over the winter.

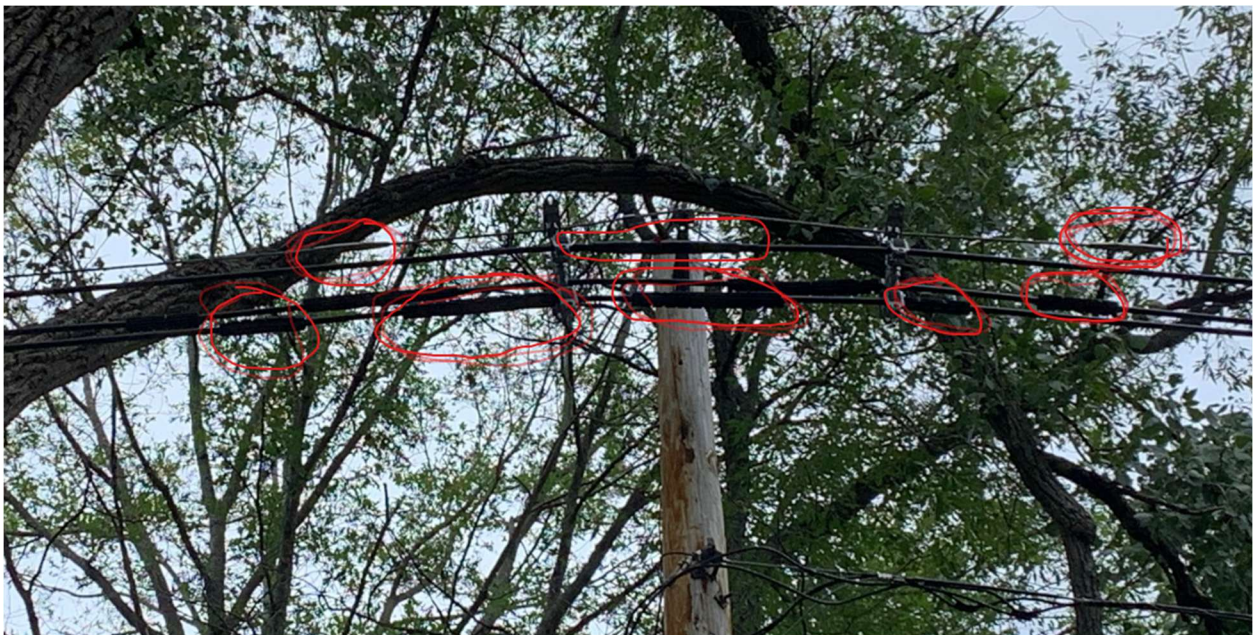
The circled areas are where the line had sustained damage in the past and needed repairs.

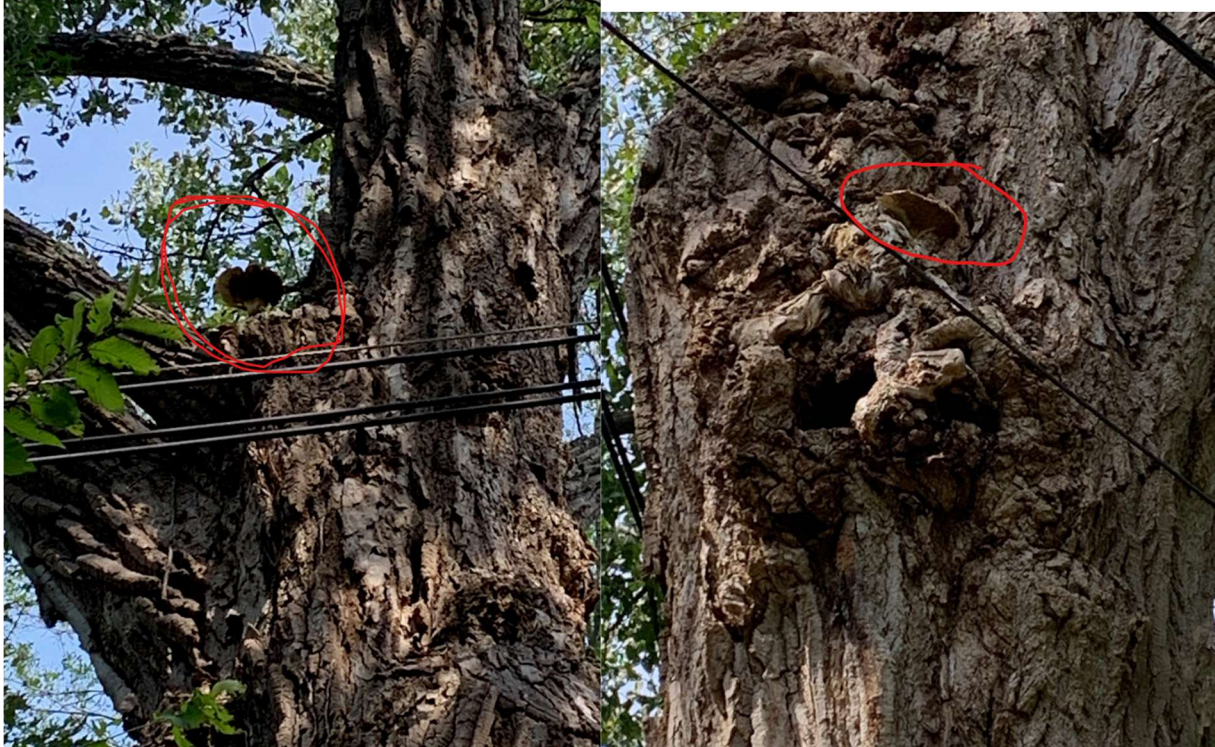
More concerning than the weak wooded nature of the species itself is the potential for catastrophic failure of the tree.

Circled are the reproductive structures of a polypore fungi which infected the tree long ago. It has been slowly decaying the inside of the tree at that major lead junction and the trunk of the tree below. The result of either of these areas failing will be main lines down and multiple broken poles. The customer at 85 Lake Buel Rd would not be able to leave their house for an extended period of time and the road would be impassable until cleanup and reconstruction could be completed. The resulting outage would affect all of Lake Buel Rd and parts of New Marlborough.
