LIMITED HAZARDOUS BUILDING MATERIALS INSPECTION FORMER HOUSATONIC SCHOOL 207 PLEASANT STREET GREAT BARRINGTON, MASSACHUSETTS

January 29, 2019

TRC Project No. 293334-00HAZ-300001

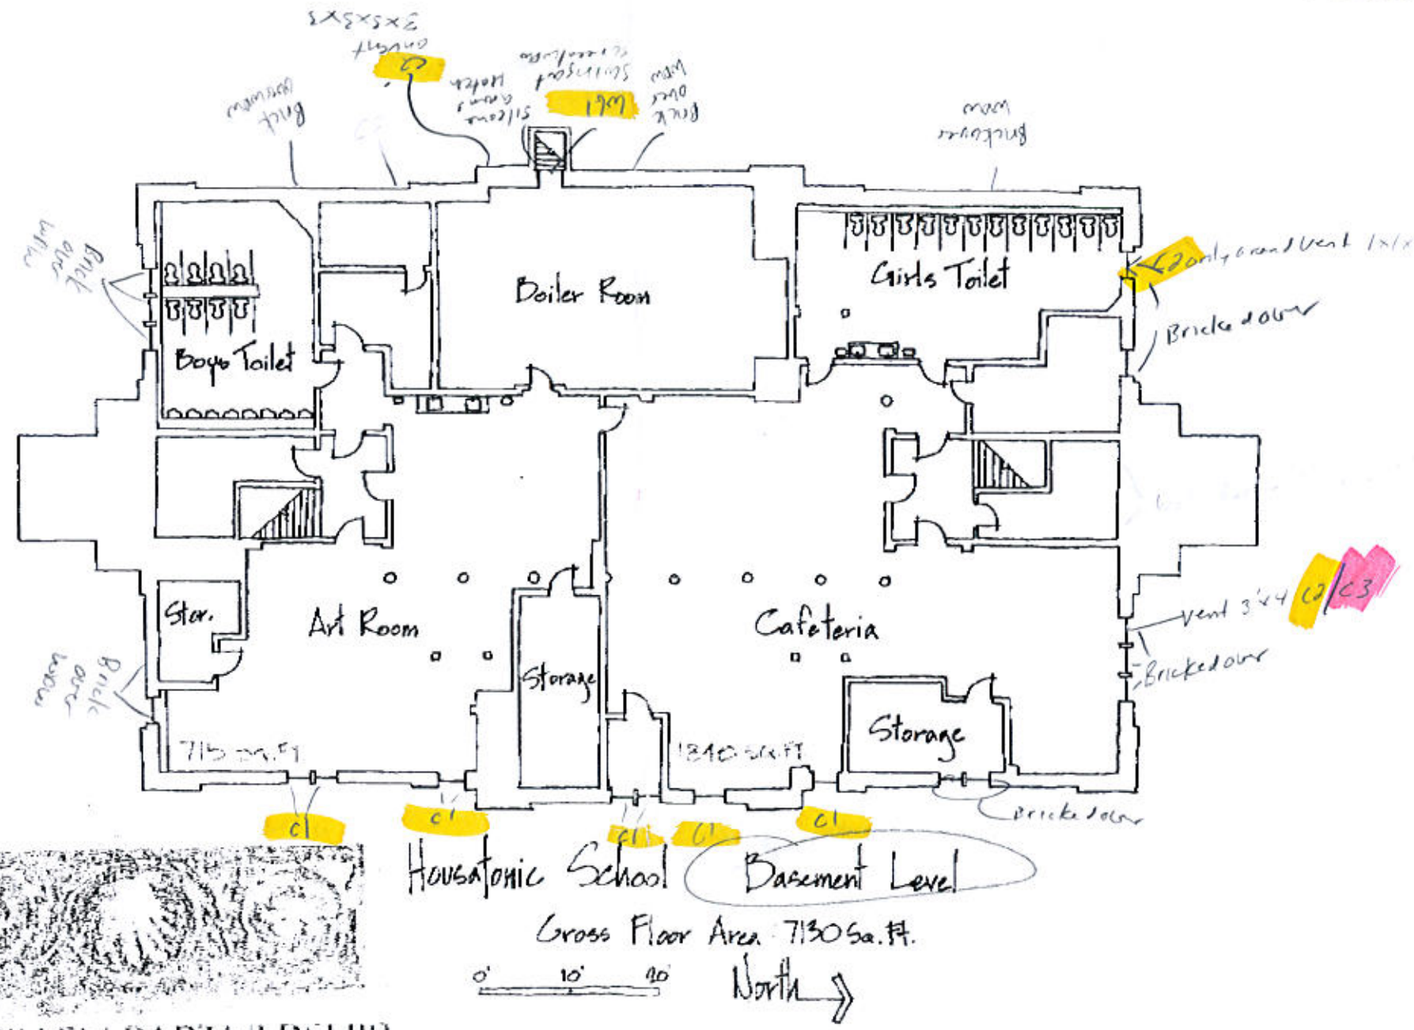
A Side

✓✓ C1 - white caulk around Basement wdws
✓✓ C2 - white caulk around louvre vents
✓✓ C3 - OK Gray caulk around louvre vents
✓✓ WG1 - Basement wdw Glaze

Basement wdws - Plywood over all (mikd access)
6'x4' = single
6'x8' = dable
Assume WG1 on all

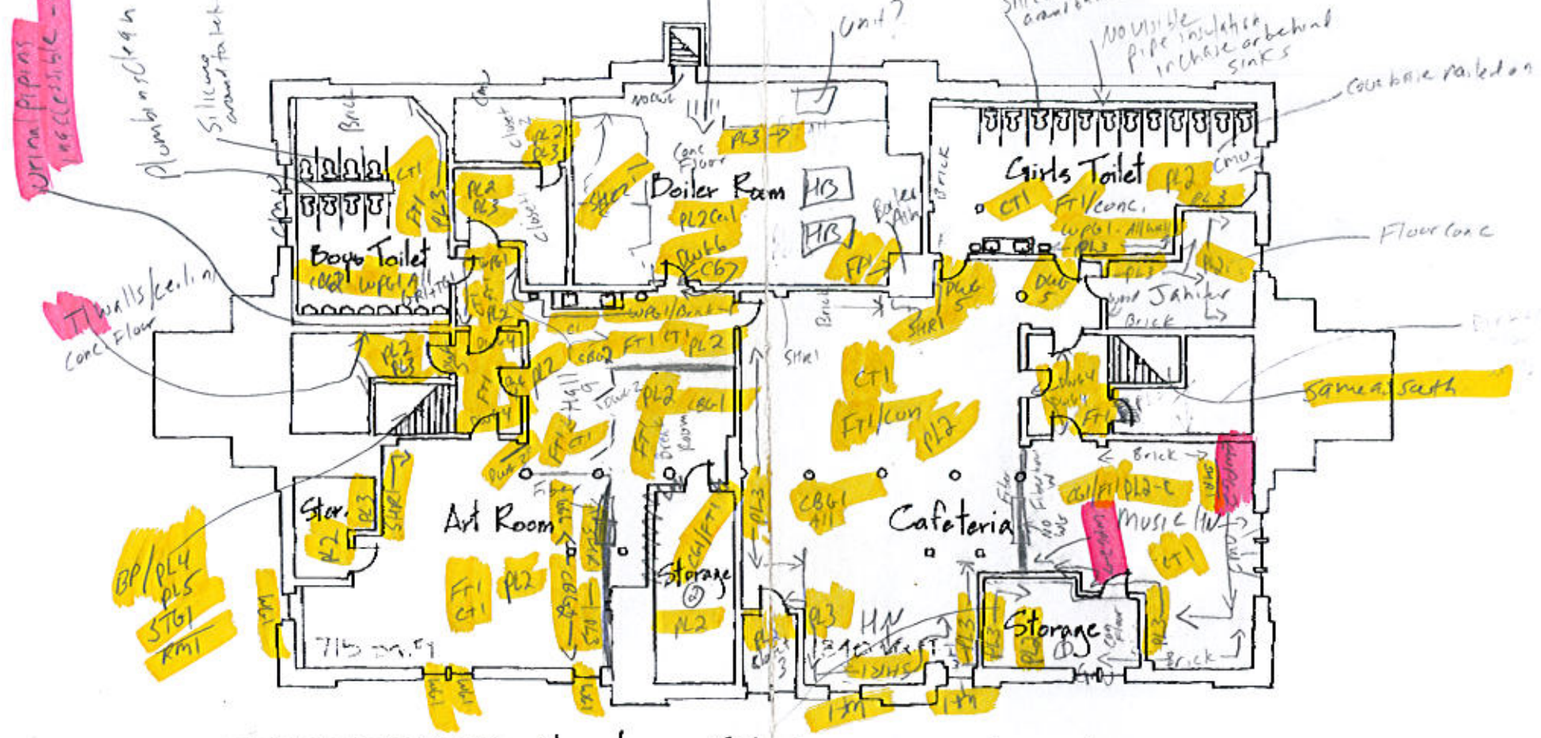
Housatonic School Basement Level

- Assume Urinal Pipes
- All Pipe Abated - Fibreglass/PVC
- Bulletin Boards - mech Fixed
- Ceilings - 9' high
- All Perimeter Exterior Walls are brick unless noted
- Assume Inaccessible insulation glues in Herman Nelson Heating units = HN

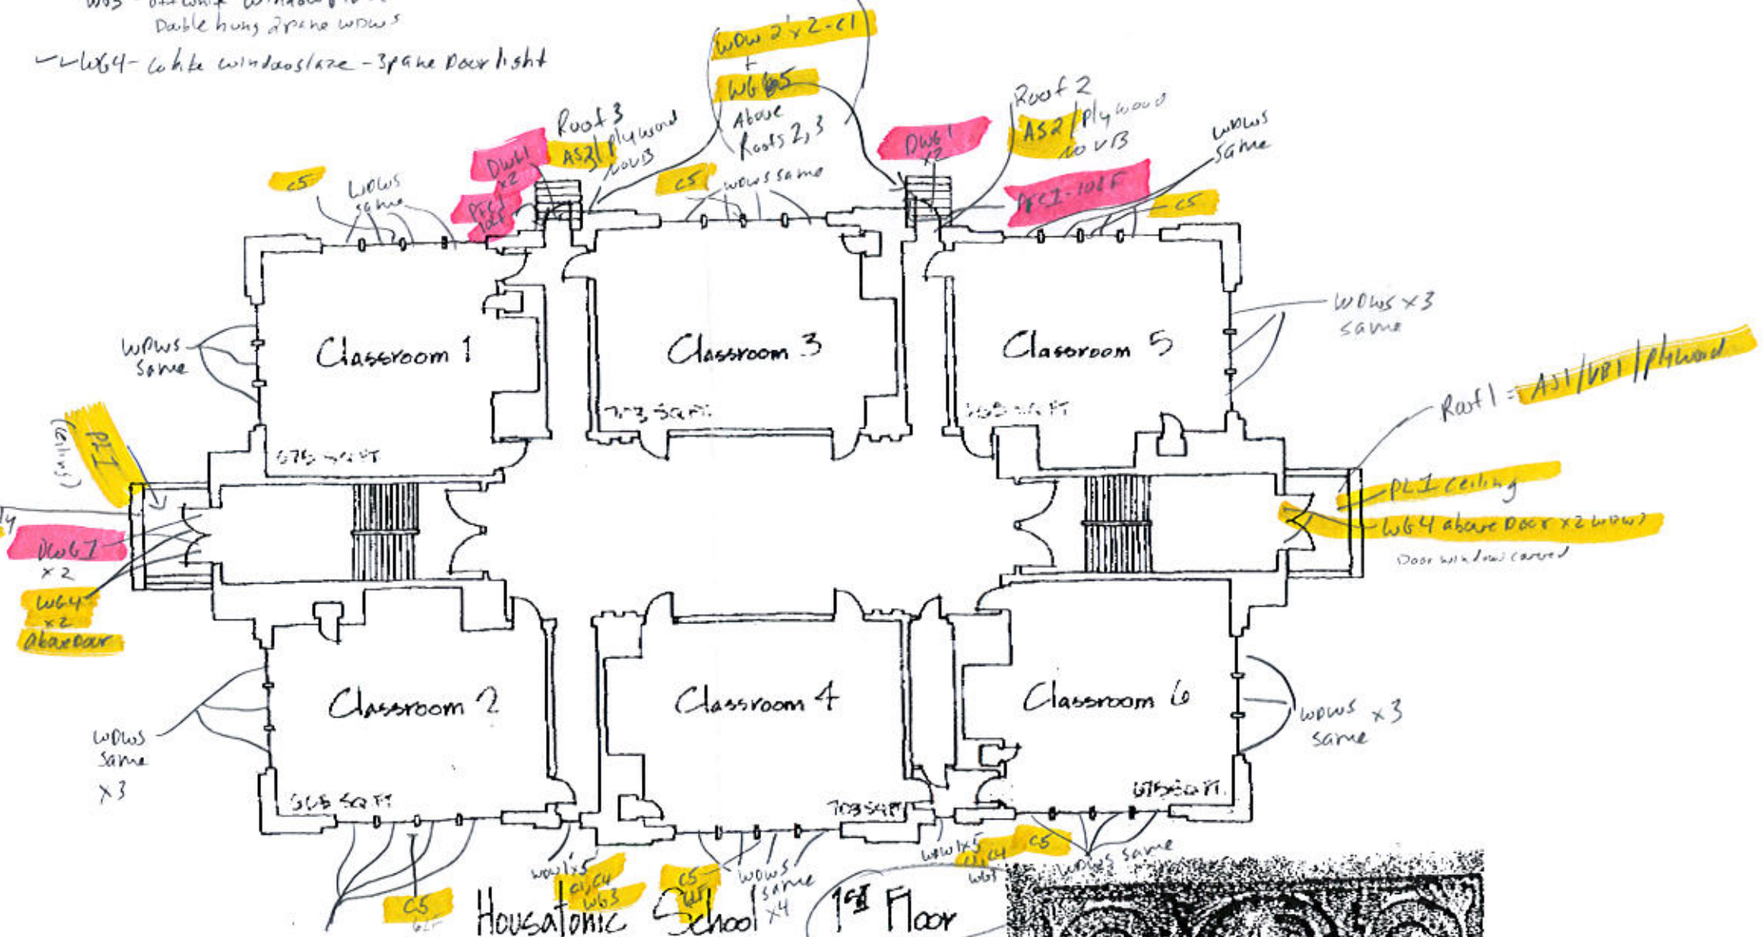
Aside

- AS1 - Black w/white Asphalt Shingle
- VB1 - Black tar paper Roof Vapor Barrier
- DWB1 - Door window glaze - offwhite Exterior 8×30"
- WG5 - 6pane wdw glaze
- AS2 - Black w/Black - Asphalt shingle
- AS3 - Black w/green/Red Asphalt shingle
- PFC1 - Black perimeter Flashing Cement
- C4 - White caulk around metal storm wdw
- C5 - Grey Vent caulk - pliable
- WG2 - Offwhite window glaze on double hung 2+6pane windows
- WG3 - offwhite window glaze Double hung 2pane wdws
- WG4 - white window glaze - 3pane door light

Same =
Each wdw (x4)
8'x4'
Double Hung
Bottom - 2pane (WG2)
Top - 6pane (WG2)
C4 around original frame
C4 around Storm wdw
Assume VB tar paper behind
C5 only at under sills

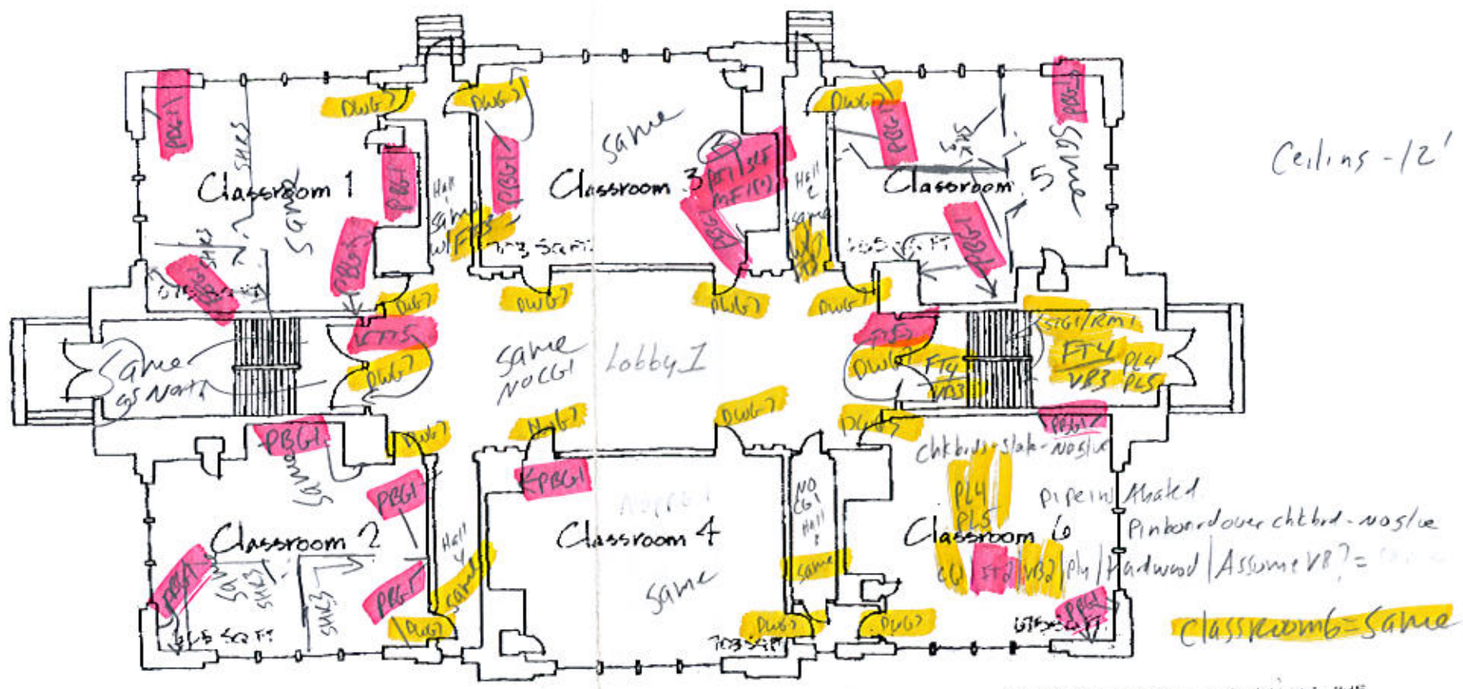
Ceilings - 12'

Classroom 1
Classroom 2
Classroom 3
Classroom 4
Classroom 5
Classroom 6
Lobby I
Same
Same as North
Same NO CG1
Same
Same
Same

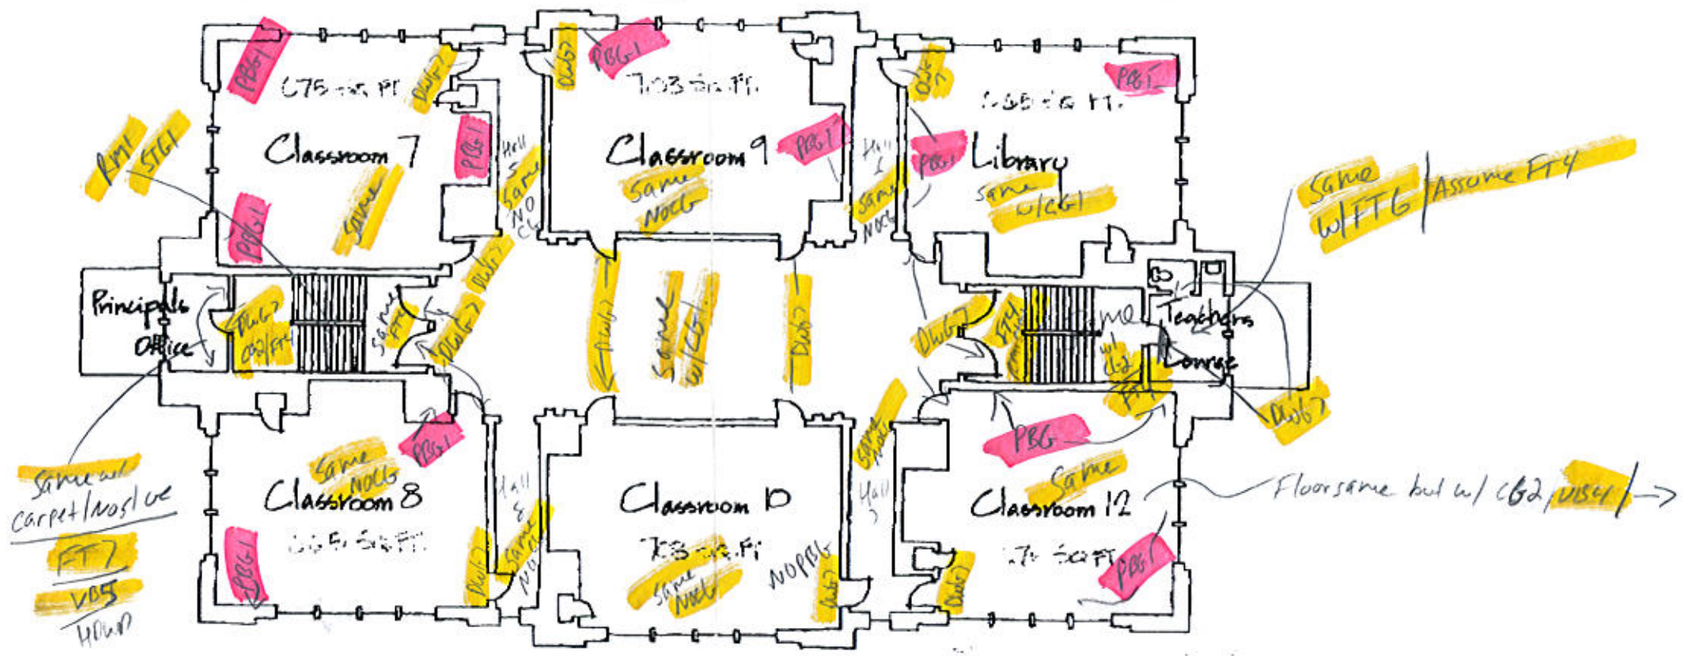
Housatonic School 2nd Floor

Attic Notes
Full Attic
Also over w/s entries
No Hvac
Wood Floors - NO VB - top of 2nd Floor Ceiling Accessible
Fiberglass Batting on Floor w FG61
Ceiling wood
Access to Hatch sketchy
Skylight in Roof
Cobined structure w/ basin? Drain?

All visible Pipe
Attached - FG/PVC

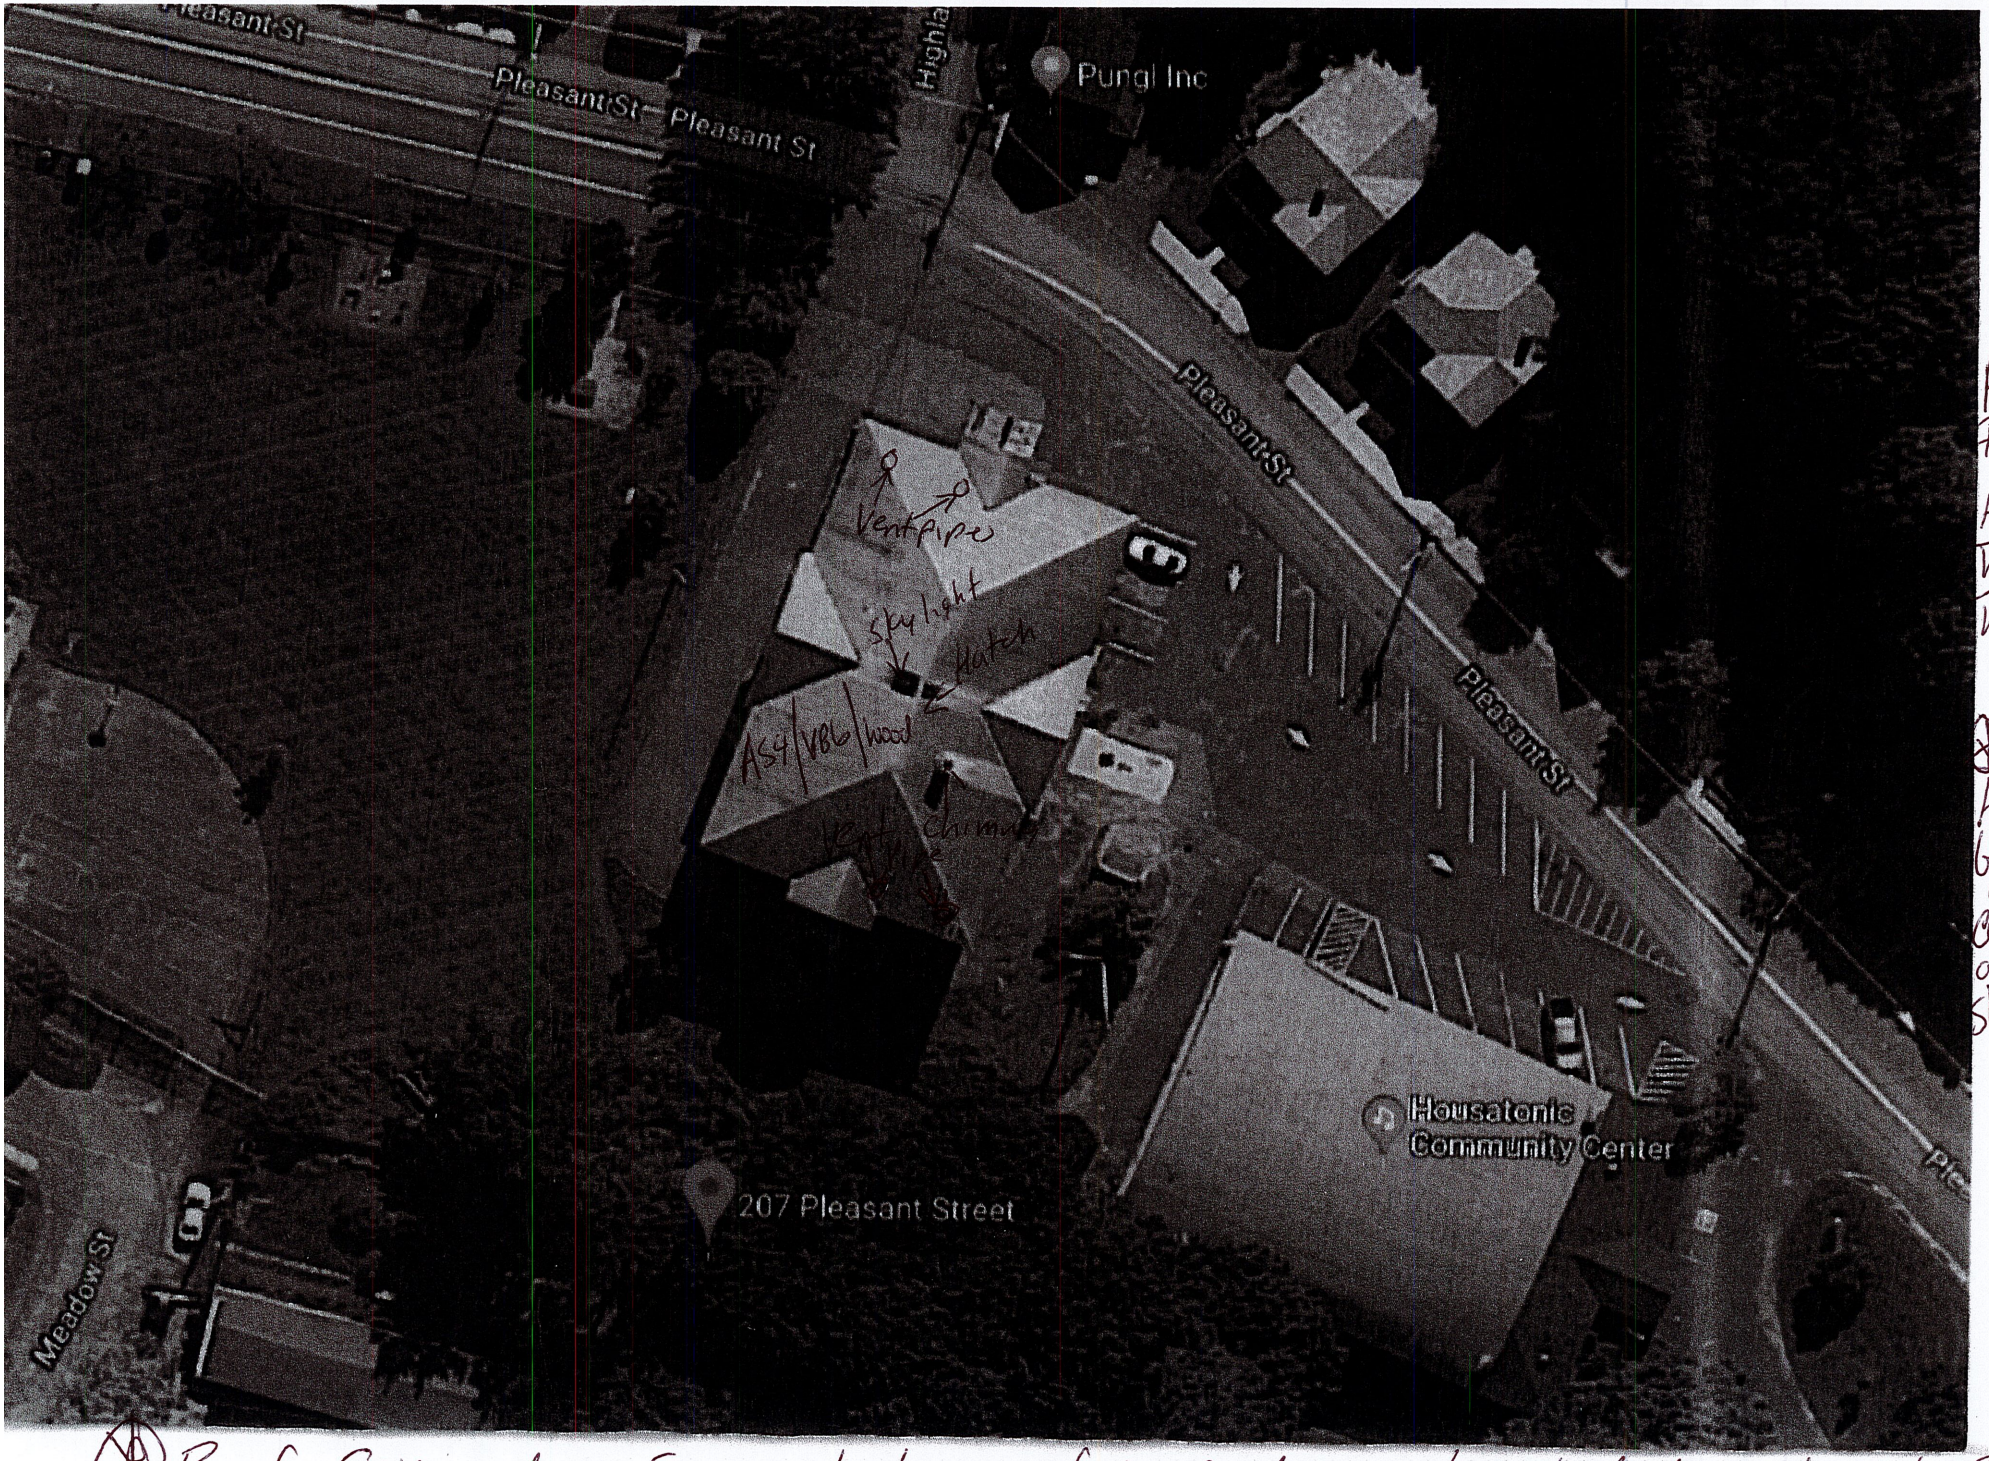
Roof Field
ASY
VB6
wood

Assume Gleams or Caulk on Skylight
