HOUSATONIC WATER WORKS COMPANY WATER SYSTEM EVALUATION

Submitted to:
Town of Great Barrington, MA

June 29, 2021

Prepared by:
AECOM

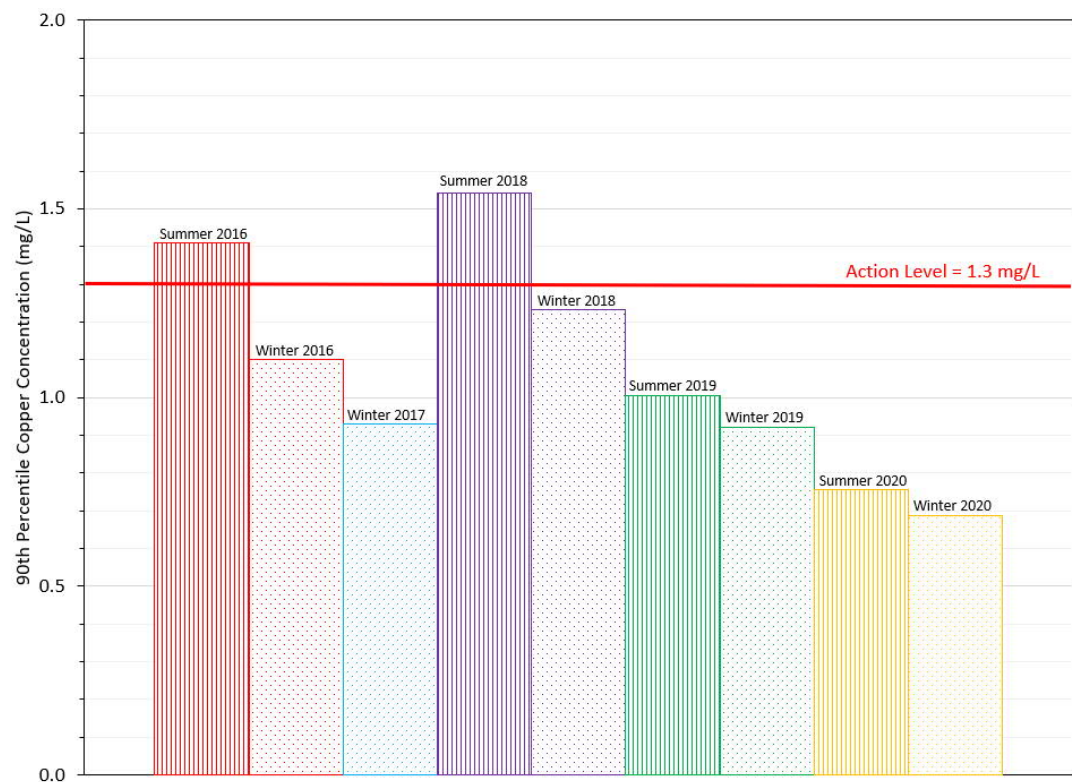
The 2016 sampling shows HWWC exceeded the action level (AL) for lead (AL = 0.015 mg/L) in both seasons of sampling and copper (AL = 1.3 mg/L) in the summer. In response, MassDEP required HWWC to submit a desktop evaluation for corrosion control treatment, a basis of design report, and a chemical addition retrofit BRP WS 34 permit application. The desktop evaluation recommended the addition of caustic to raise the pH and a blended phosphate as an inhibitor.

Another exceedance was reported for copper in the summer of 2018. In response, MassDEP issued an Administrative Consent Order for corrosion control equipment to be installed which included a pH control chemical and an addition of a blended ortho/polyphosphate. Although approved, no corrosion control equipment has been installed. At the time of this report, there is no plan for corrosion control in place. HWWC asserts that improved sampling procedures, a reduction in the application of chlorine for primary disinfection, and the effects of its storage tank re-piping, has sufficiently reduced lead and copper to below Action Levels. HWWC's 2020 Sanitary Survey stated by not adding the components for corrosion control, the water system was in violation of their 2018 Administrative Consent Order and would reevaluate the conditions of the consent order based on the color and corrosion evaluation conducted by Cornwell Engineering Group (Appendix D). One of the conclusions of the Cornwell Engineering Group evaluation was if the lead and copper cannot be controlled under current conditions, the addition of orthophosphate may need to be evaluated.

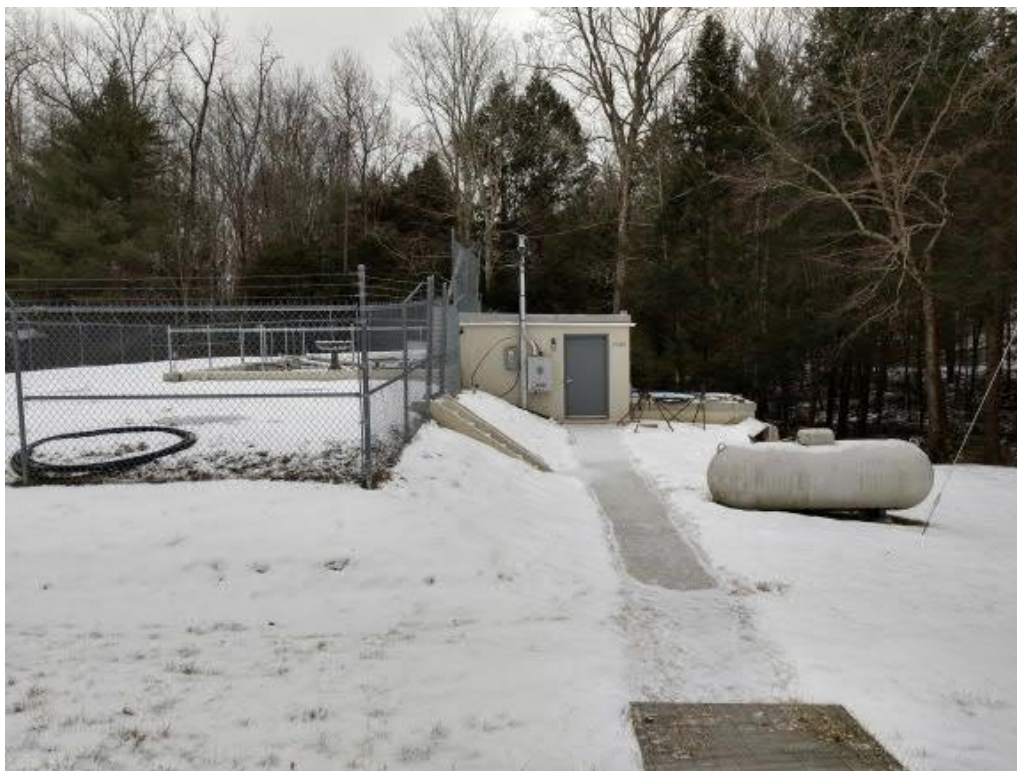
Photo 1: Water Treatment Plant & Slow Sand Filter Facility Photo 1

- The Water Treatment Plant Building & Slow Sand Filter Facility was designed and constructed around 1940 and displayed areas of staining and other signs of typical wear that is often exhibited on a structure of its vintage (See Photos 1 through 10), but the elements of the structure that were visible did not show any major signs of structural deficiencies that would impede on the functionality of the facility.

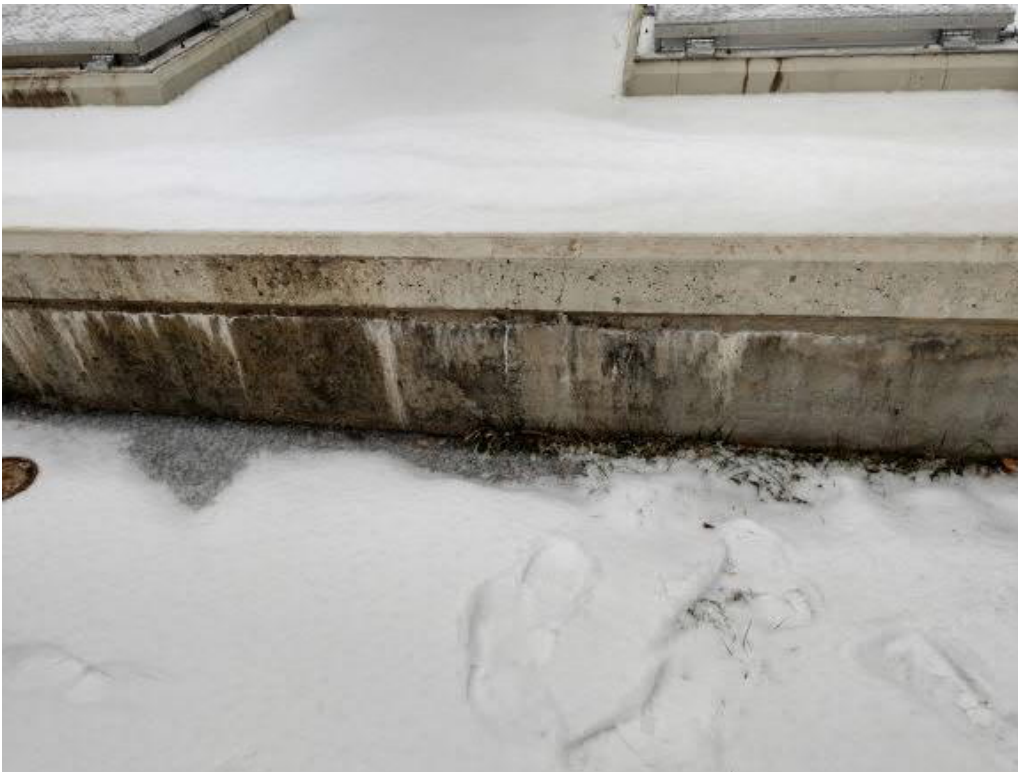
Photo 11: Existing Chlorine Contact Tank Photo 1

- The Chlorine Contact Tank, which was designed and constructed around 1997, was covered with snow at the time of inspection (See Photo 11) and was not drained and therefore the top slab and the interior structural elements were inaccessible for a visual assessment.

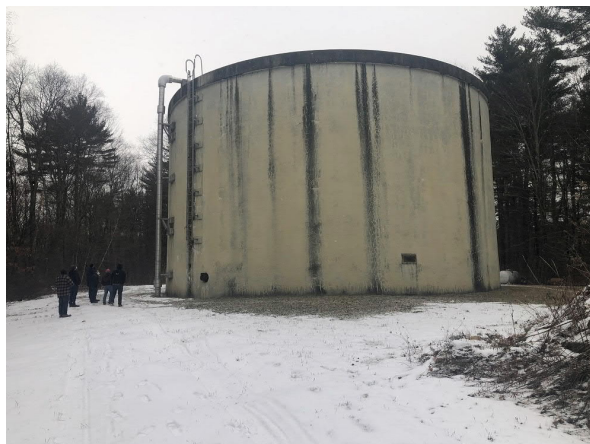
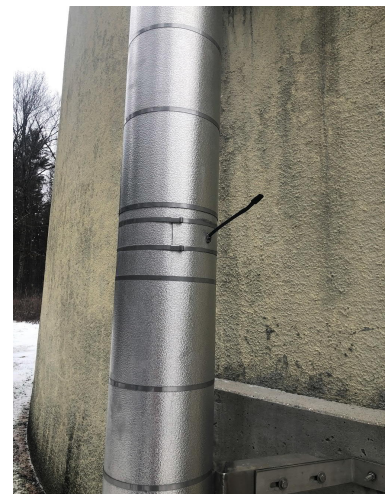
The storage tank is located on a hill behind the main facility and the reservoir. The tank has no pumps or water circulators as part of the system. The external piping is heat traced with an external pigtail that is not connected to power. The water tank has no utility service or power run to its location from the main facility at the dam.

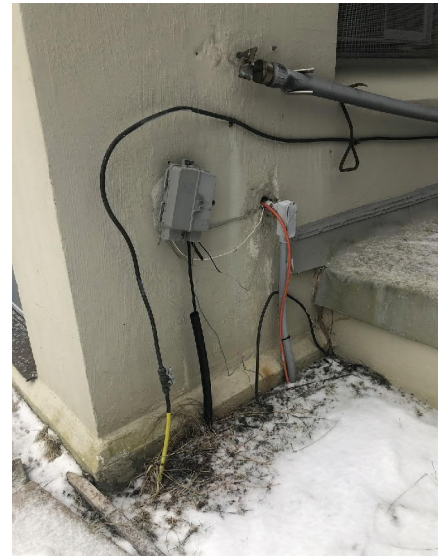
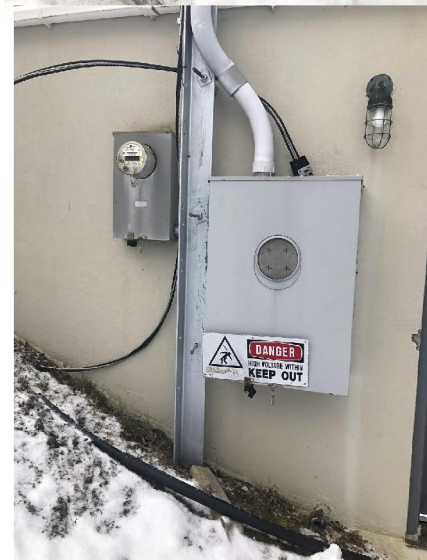
As you can see to the right, both telephone and cable are poorly installed and maintained. The LP tank gas feed is also loosely run above the telephone termination enclosure.

Also, you can see from the photo to the right there is a triplex cable on top of the 400-amp meter socket. It does not go into the enclosure rather it has a 3-prong range plug attached to it. It's unclear what it actually plugs into,

I had asked the Owner what it was being used for and he said it was use when the tanks were cleaned to support the general lighting. This system is neither practical nor safe no matter how it is used.

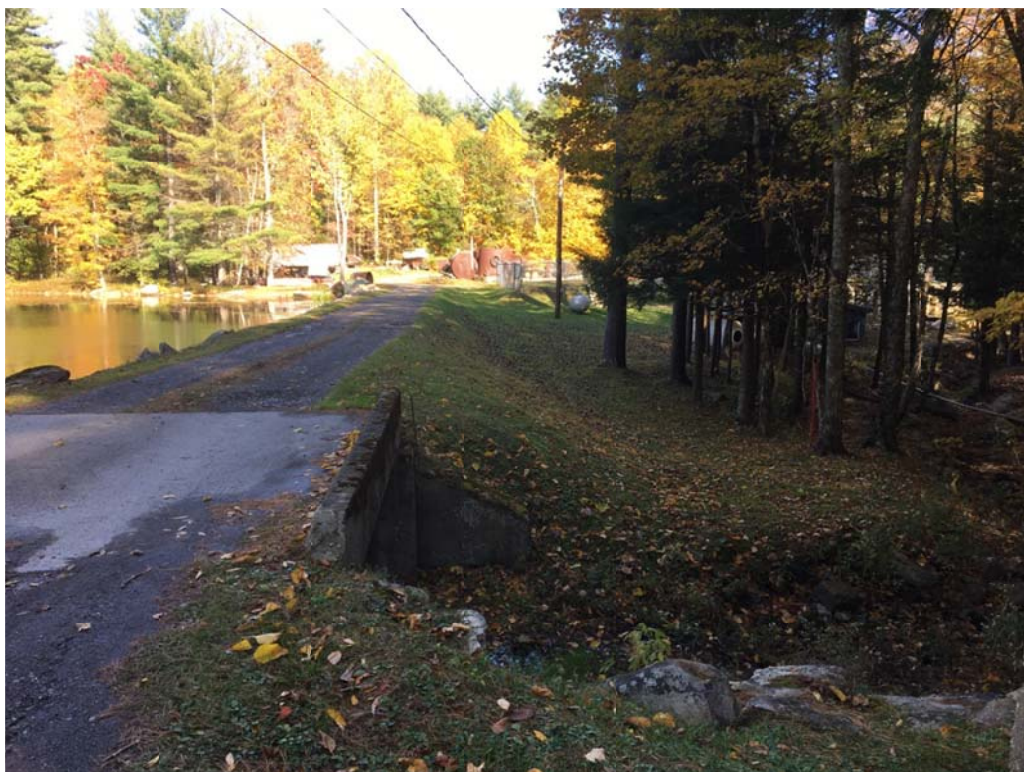
Photo 1 Crest of dam from right (West)

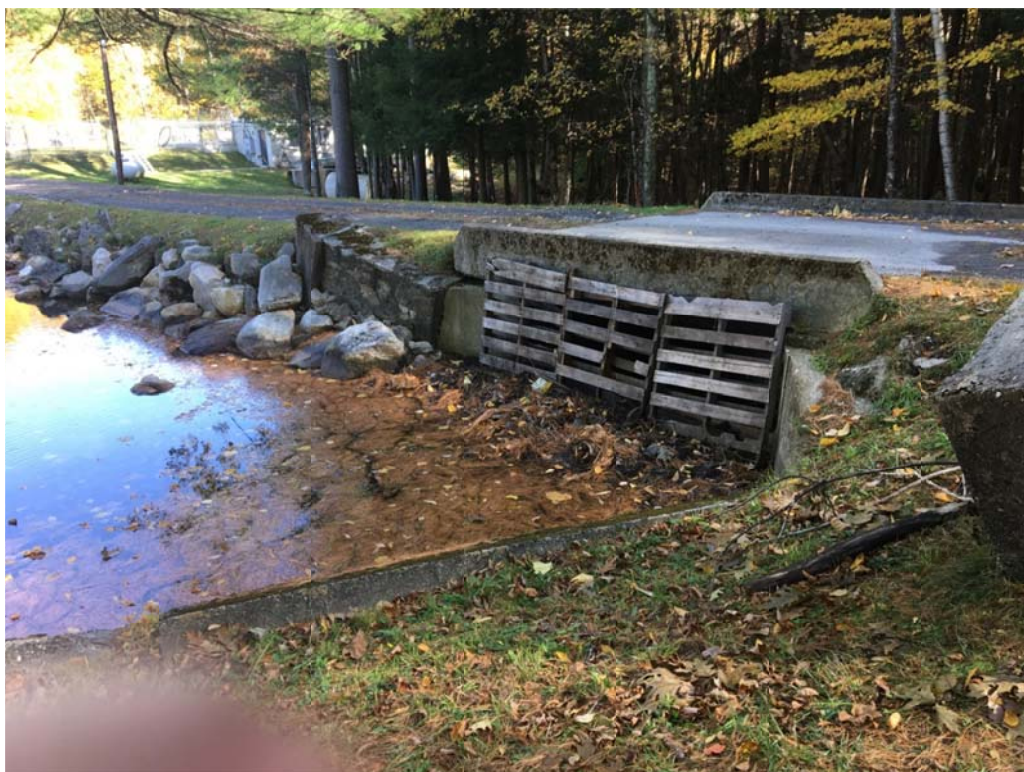
Photo 3 Spillway from upstream

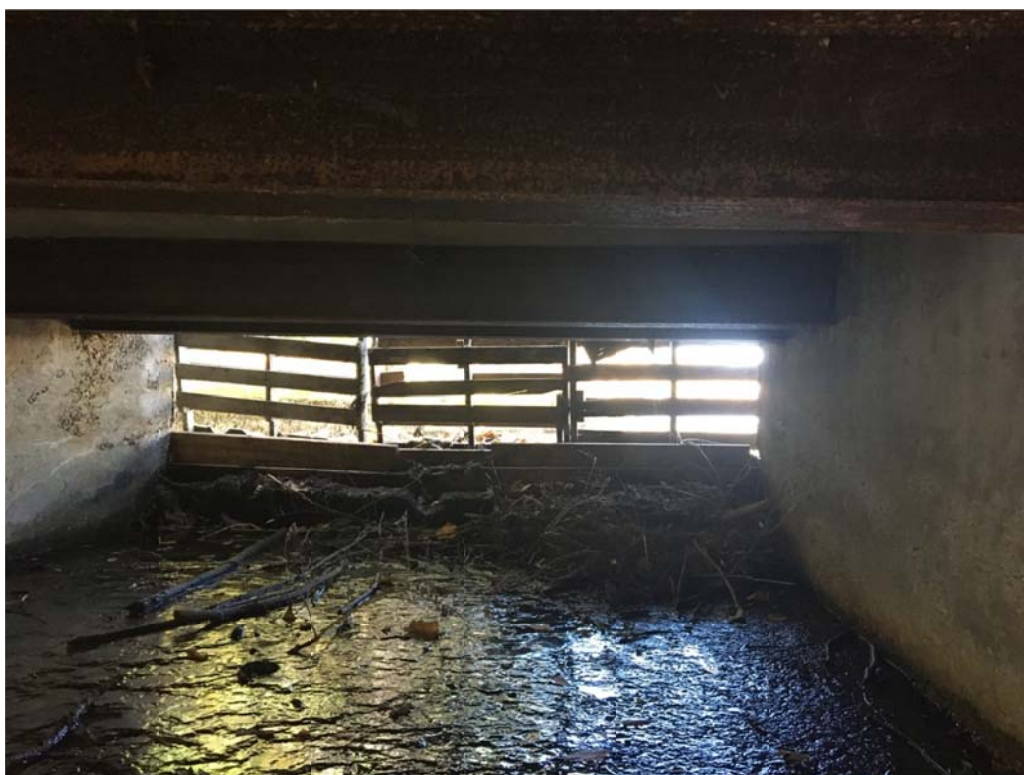
Photo 4 Spillway and underside of bridge from downstream

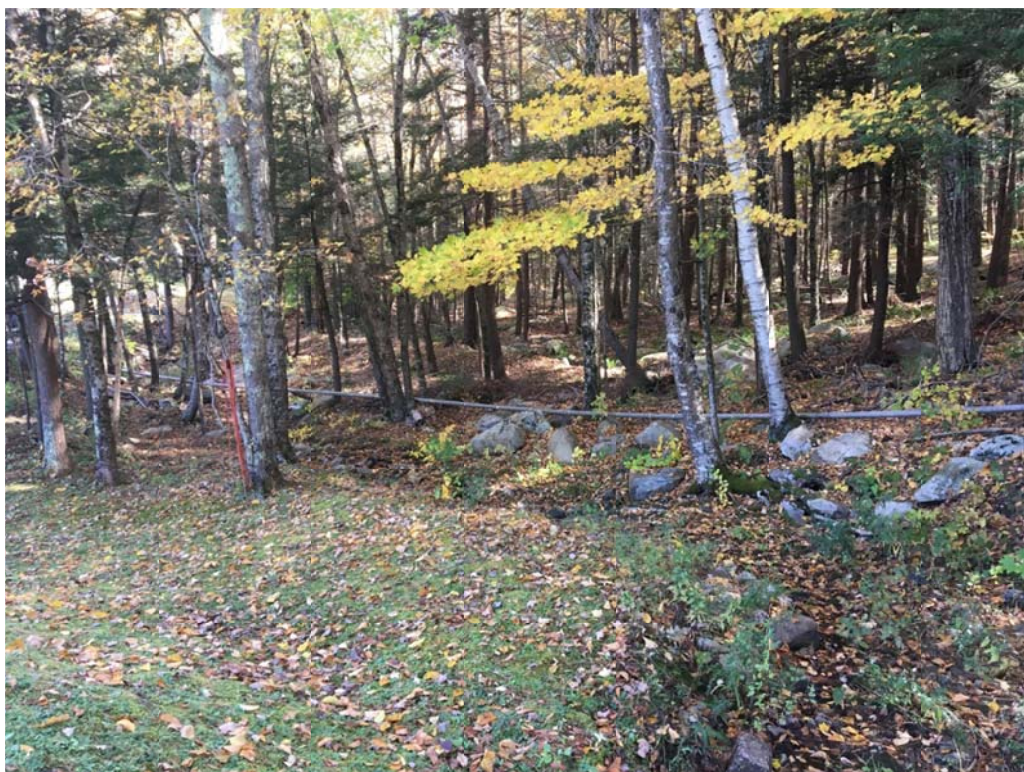
Photo 5 Downstream Channel

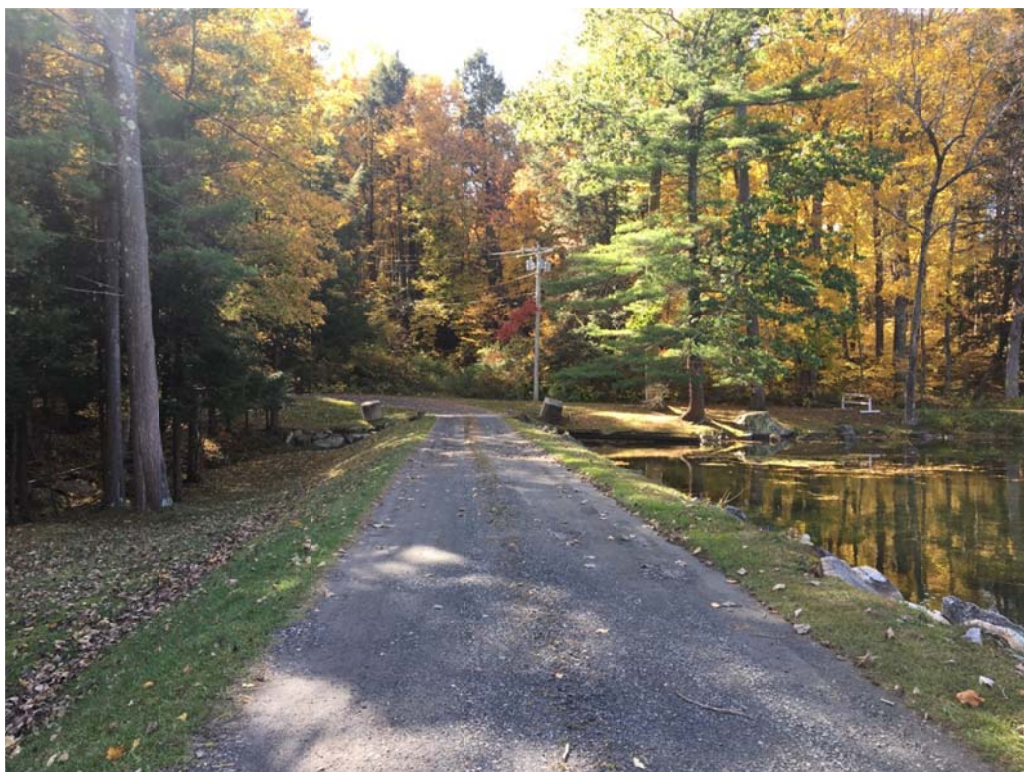
Photo 7 Crest of dam from left (east)

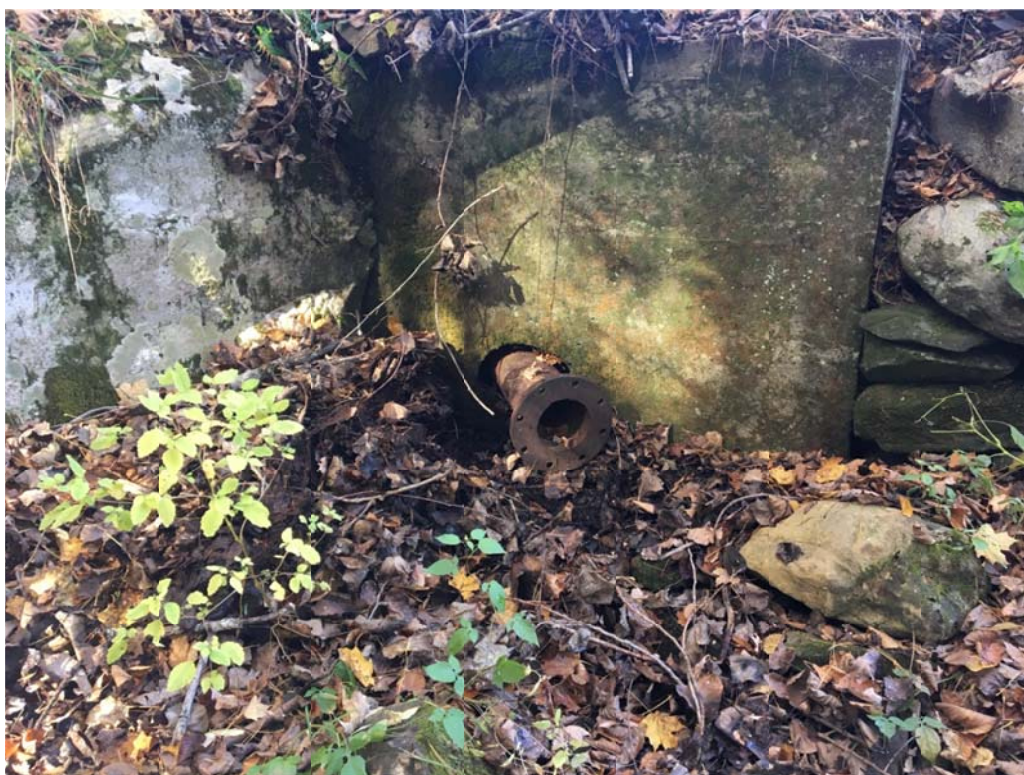
Photo 8 Headwall and low level outlet

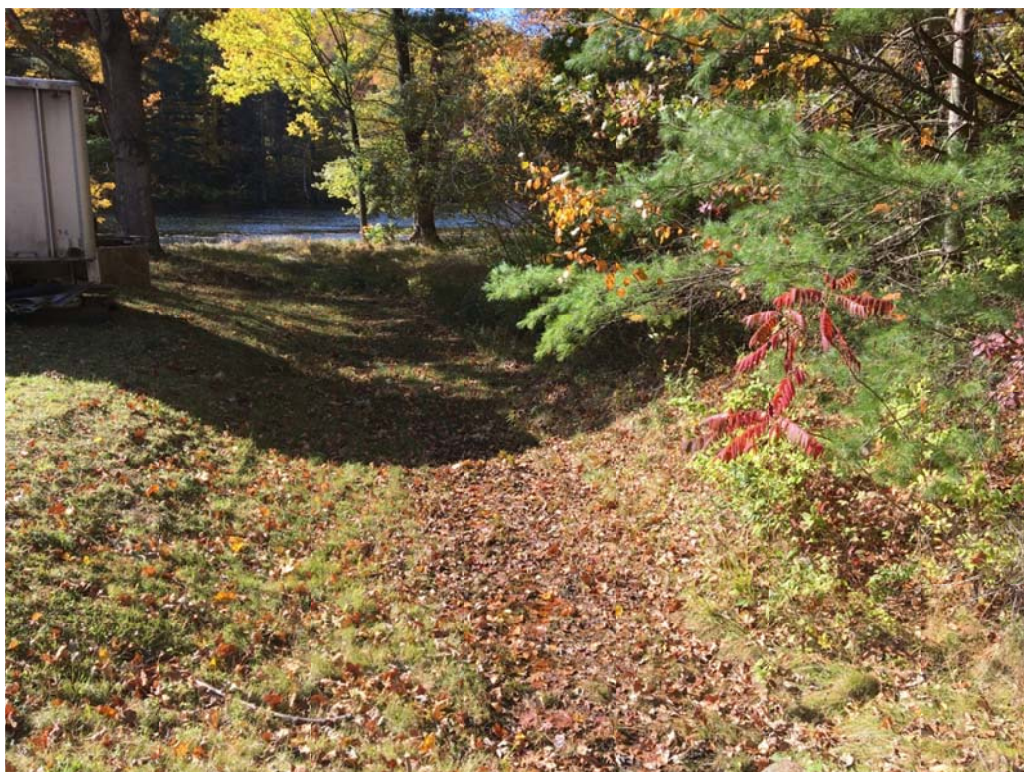
Photo 9 Emergency spillway channel

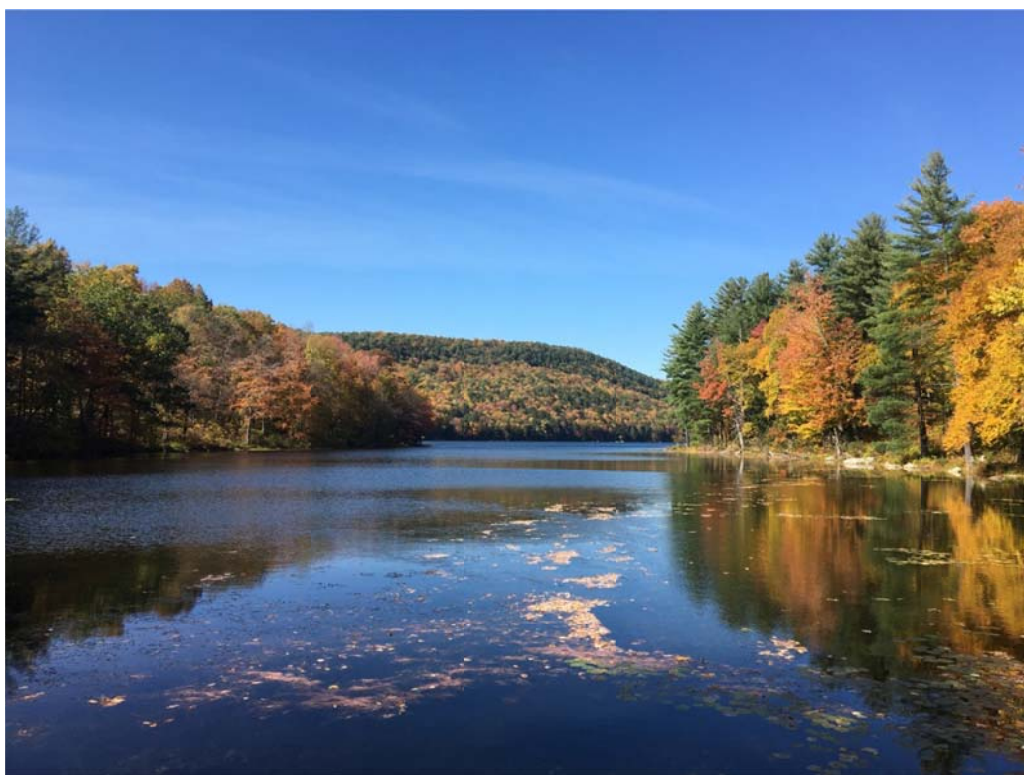
Photo 10 Impoundment

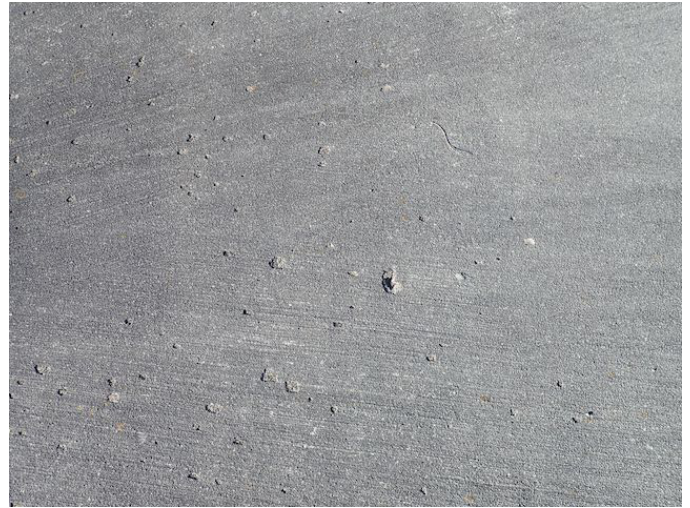
20 *Roof Having Adhesion Lost Of The Cement Based Protective Coating*

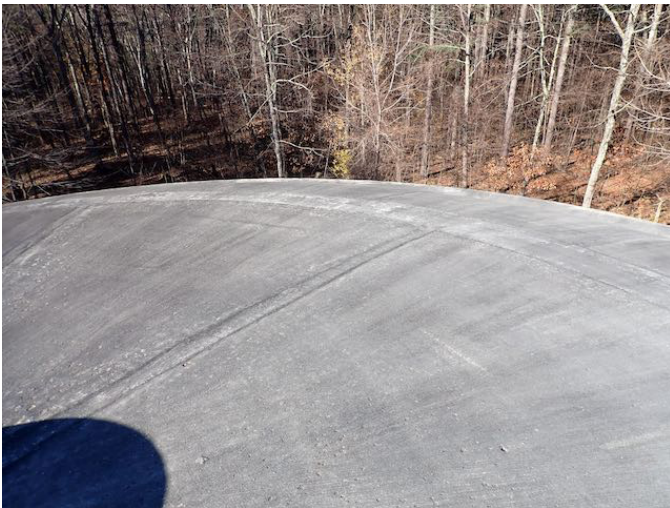
21 *Roof Having Adhesion Lost Of The Cement Based Protective Coating*

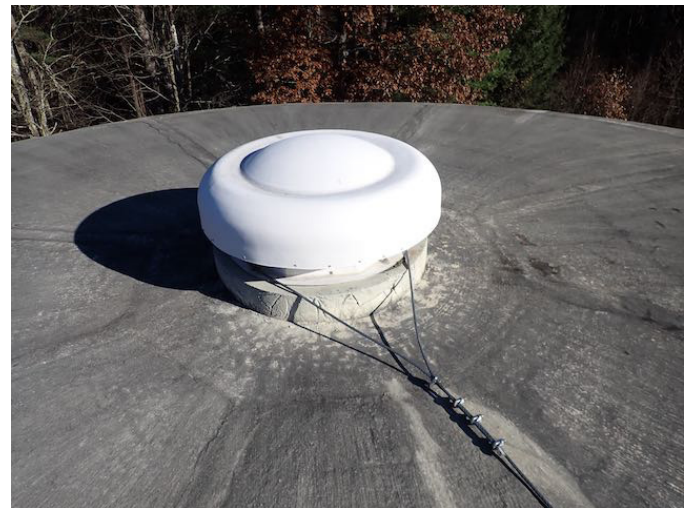
22 *Steel Cable Secured Around The Vent*

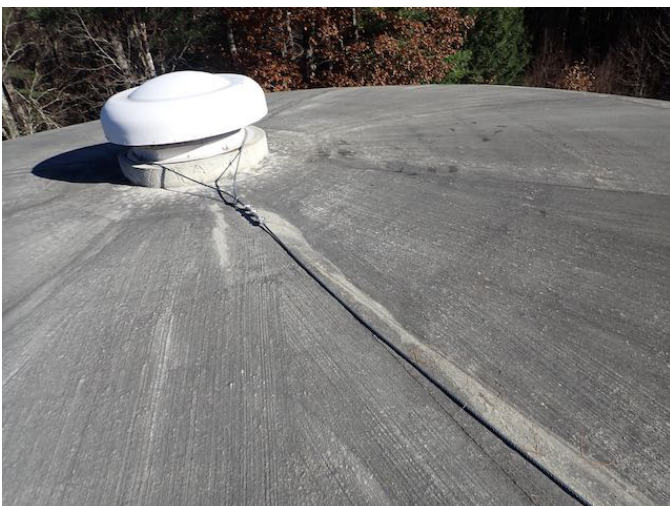
23 *Steel Cable Secured Around The Vent*

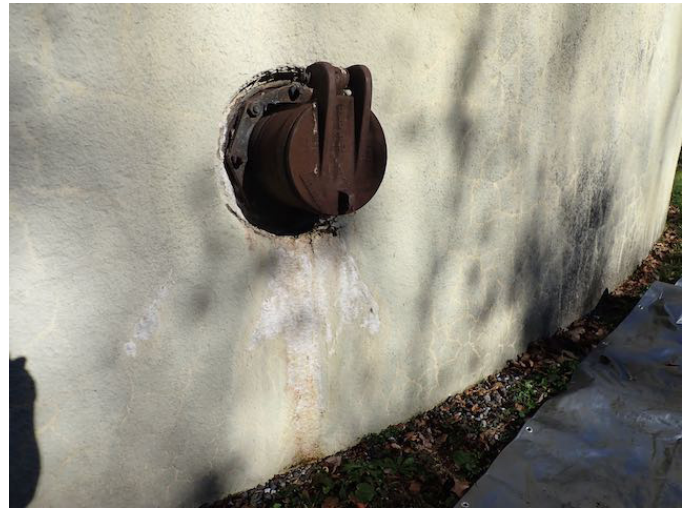
34 *Overflow Pipe Having A Flap-Valve*

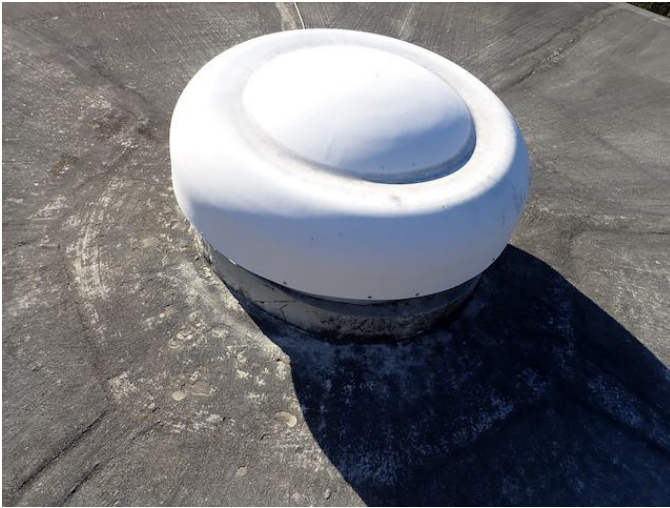
37 *Secure Vent Assembly*

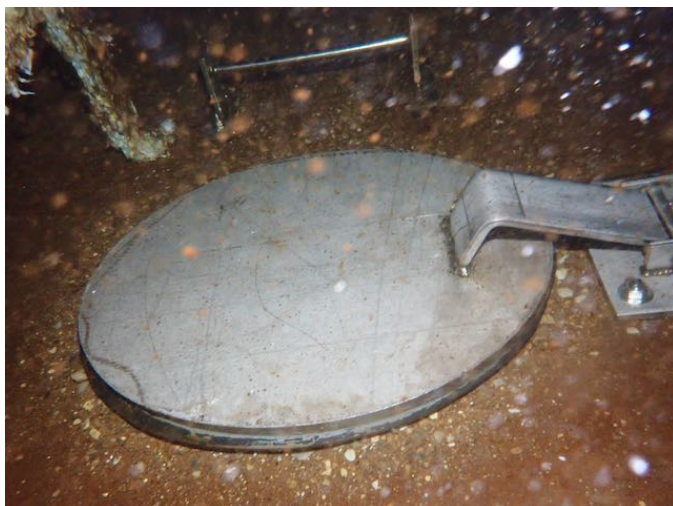
47 *Secure Manway And Grab Bar*

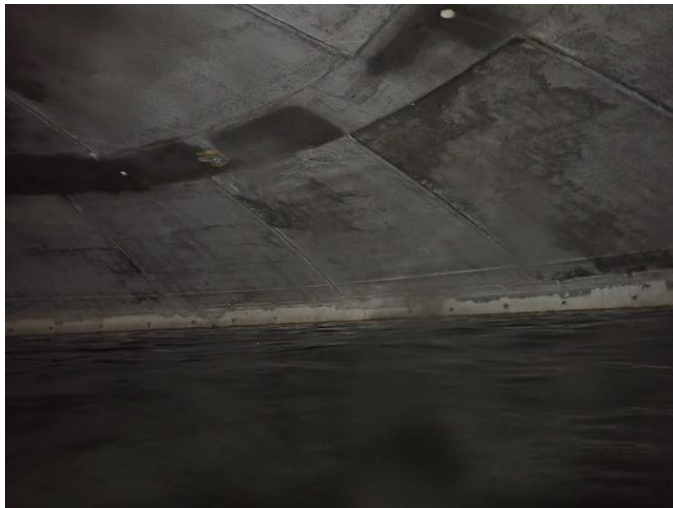
61 *Pre-Cast Concrete Overhead Panels And Concrete Filled Joints Appearing Mostly Sound*

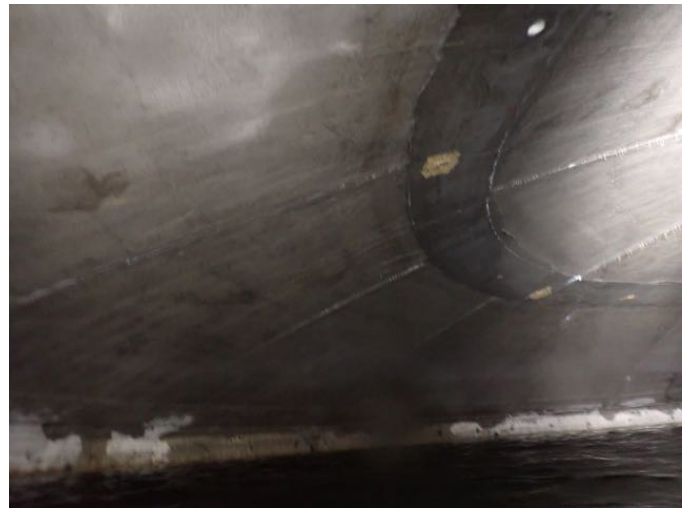
62 *Pre-Cast Concrete Overhead Panels And Concrete Filled Joints Appearing Mostly Sound*

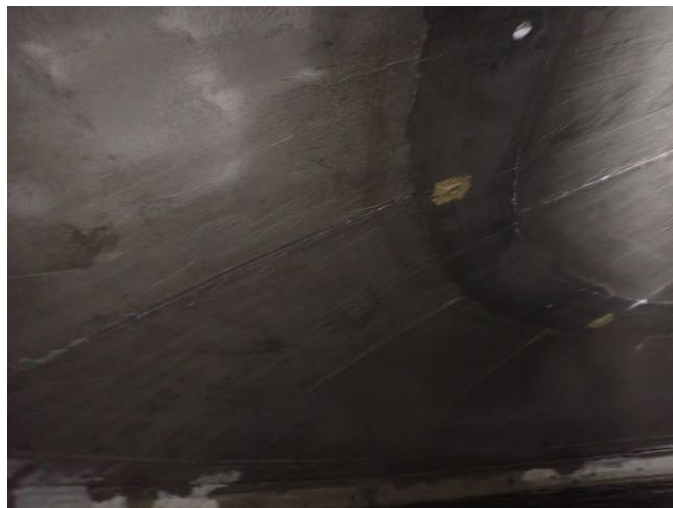
63 *Pre-Cast Concrete Overhead Panels And Concrete Filled Joints Appearing Mostly Sound*

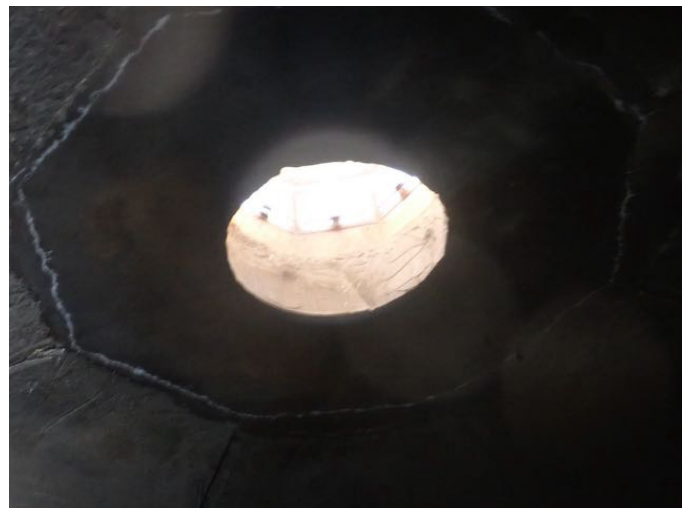
64 *Unobstructed Vent Penetration*
